Your Inspection Report

183 Princess Anne Cres
Toronto, ON M9A 2R8

INSPECTION DATE:
Tuesday, July 24, 2018

RE: Report No. 63417
183 Princess Anne Cres
Toronto, ON
M9A 2R8

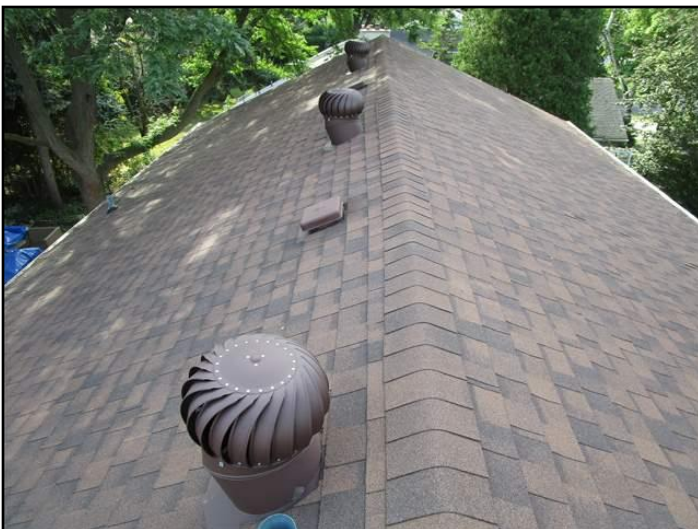
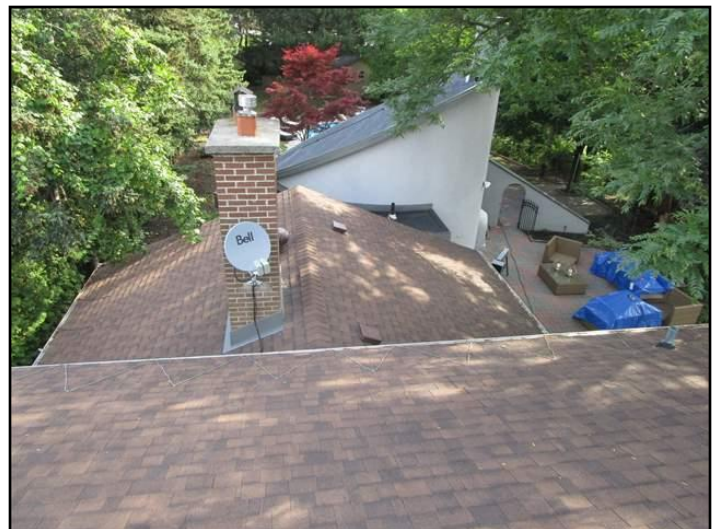
Condition: • Roof coverings wear out and are replaced every 15 years or more, depending on a number of variables. An annual roof tune-up by a qualified roofer is strongly recommended.

The sloped roof coverings appear to be within the second half of their normal life expectancy. Several more years of service are expected from these materials, although some maintenance may be required to help extend their useful life.

Roof coverings wear out and are replaced...

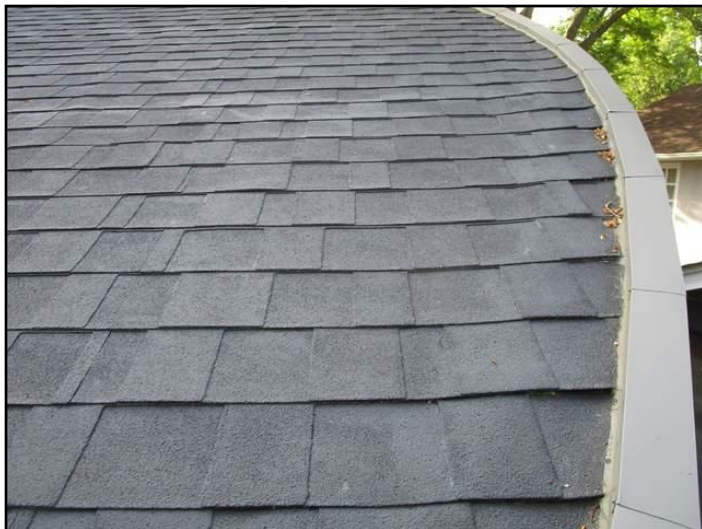
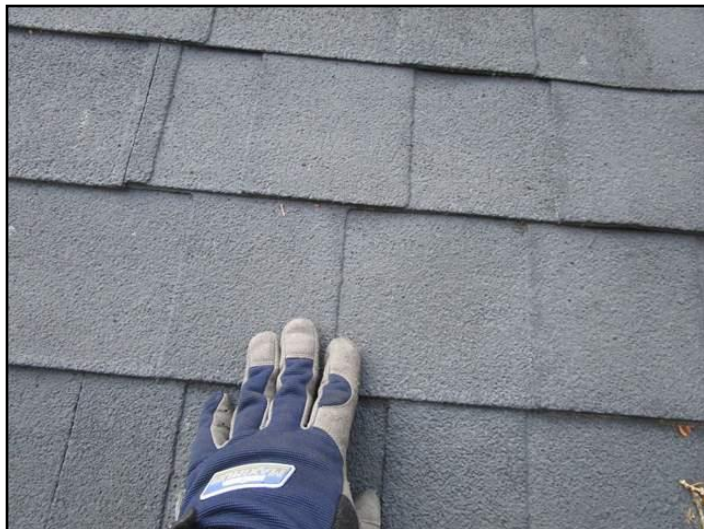
Condition: • The shingles appear to have been coated to help extend their useful life.

The shingles appear to have been coated...

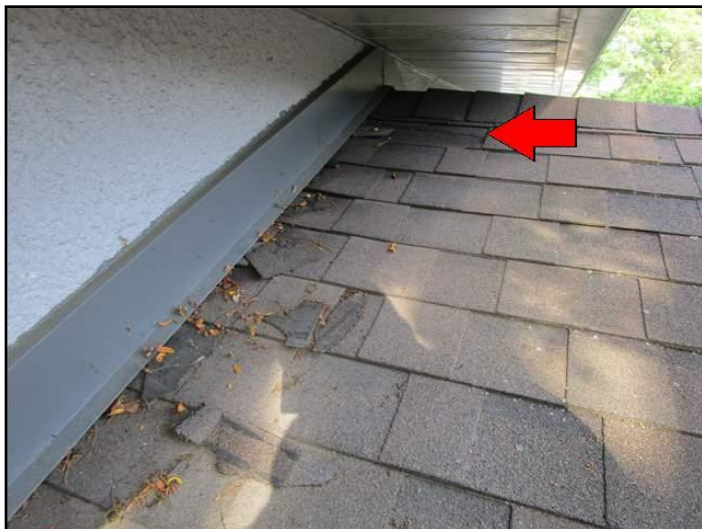
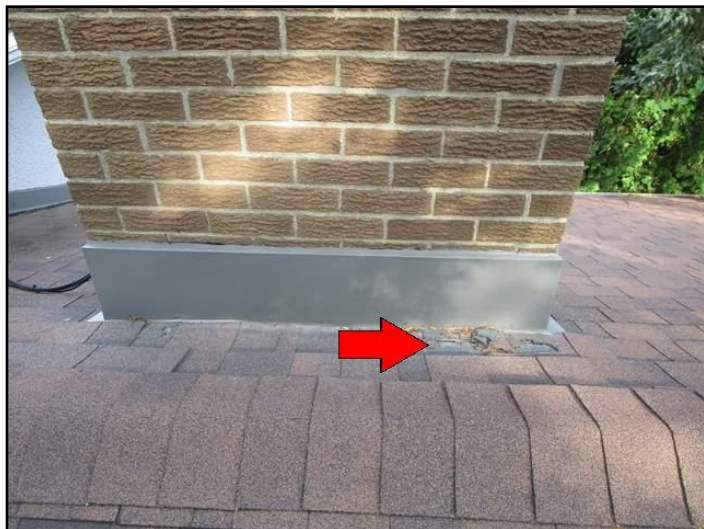
Minor shingle damage noted.

Damage

Task: Repair

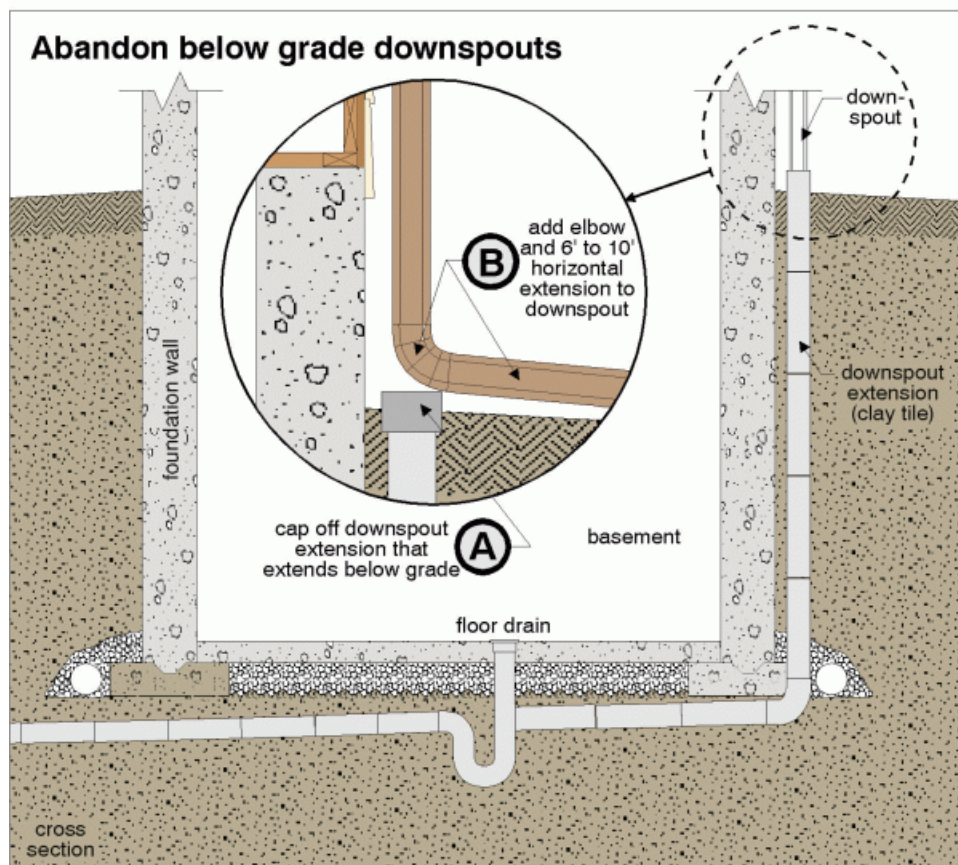
Condition: • [Discharge below grade](#)

Downspouts discharge below grade - disconnect and discharge above grade at least 2 m / 6 ft away from foundation. (Unless special dispensation has been granted by the City).

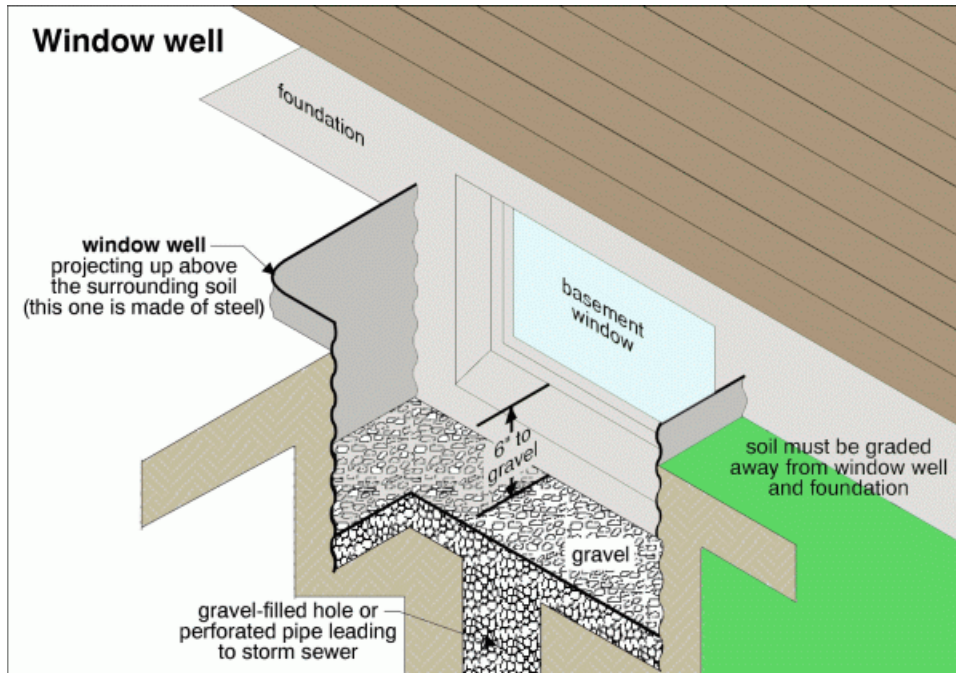
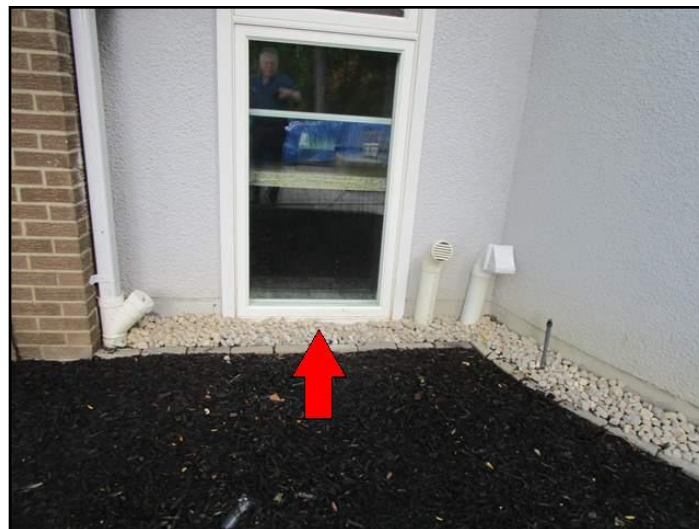
Condition: • [Missing](#)

Missing

Keep area properly sloped away from the foundation wall and clear of snow and debris to help prevent water infiltration.

Ensure sealant is in good repair.

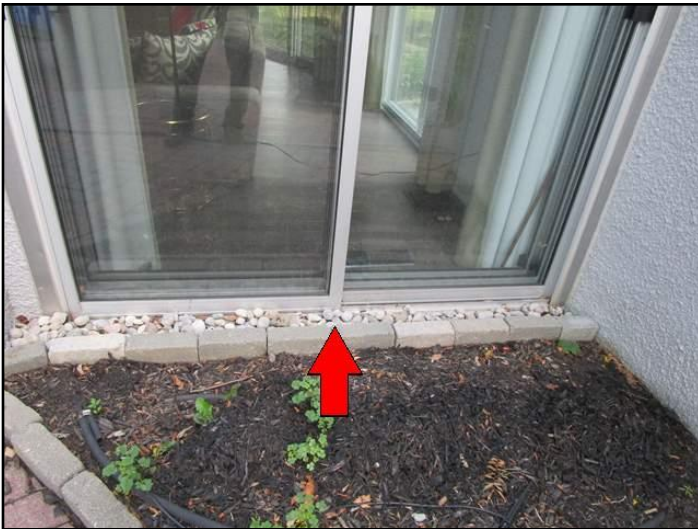
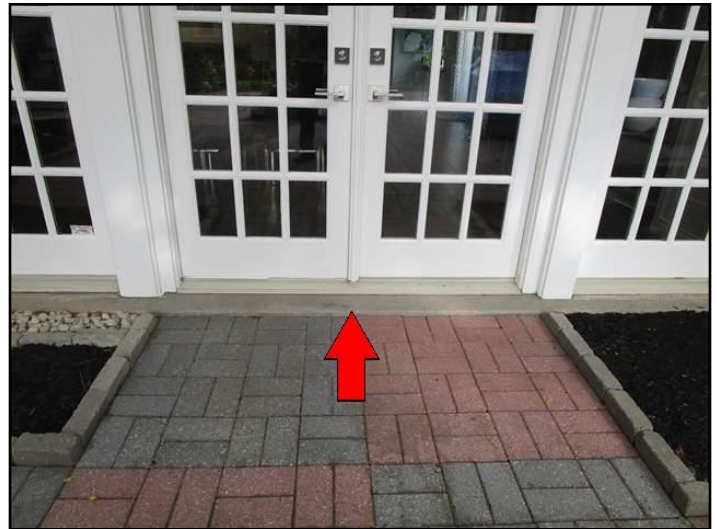
Condition: • Threshold - too low

Threshold - too low

Keep area(s) clear of snow and debris, including any drains to help prevent water infiltration. Ensure sealant at threshold is kept in good repair.

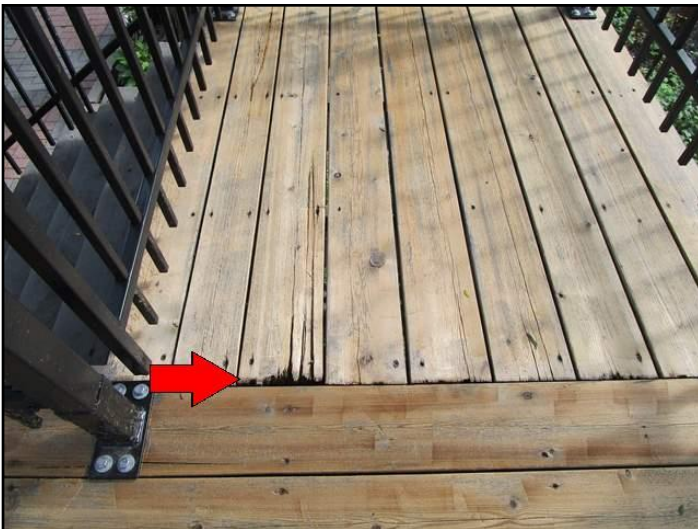
Weathered - Rot noted at various planks.

Weathered - Rot noted at various plank ends

Task: Repair

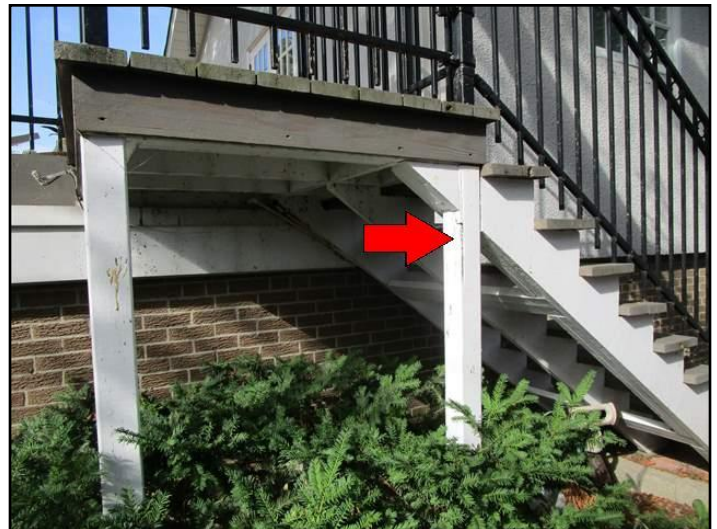
Rot at post

Time: (Damaged post should be repaired/replaced as soon as possible)

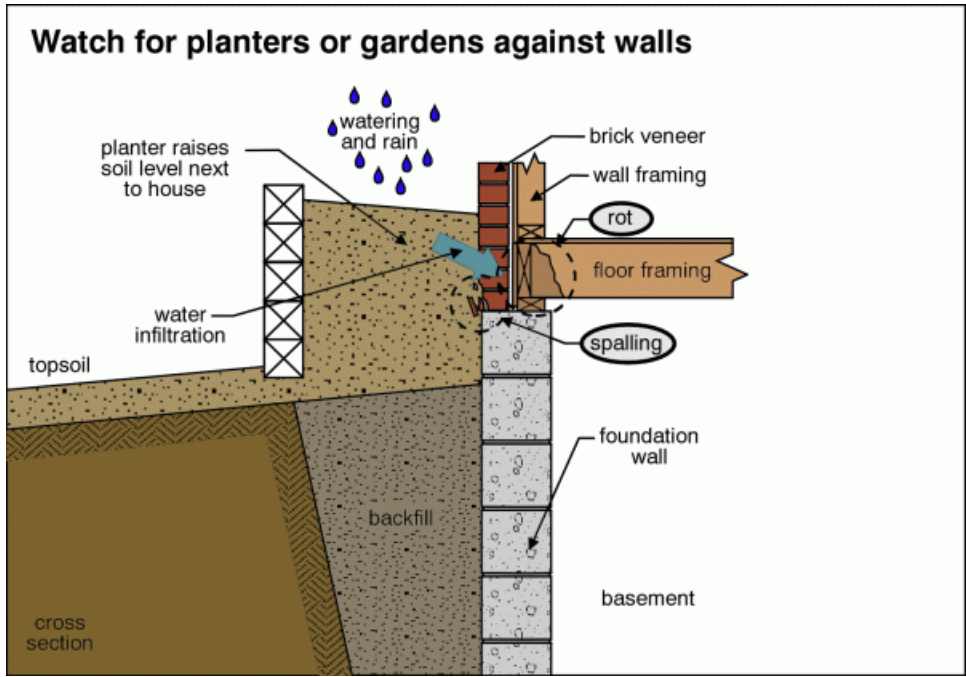
Condition: • [Planters and gardens against walls](#)

Because gardens tend to see water more frequently, these could be areas where moisture could enter the basement area. If basement leakage becomes an issue, relocation of the garden(s) may be necessary.

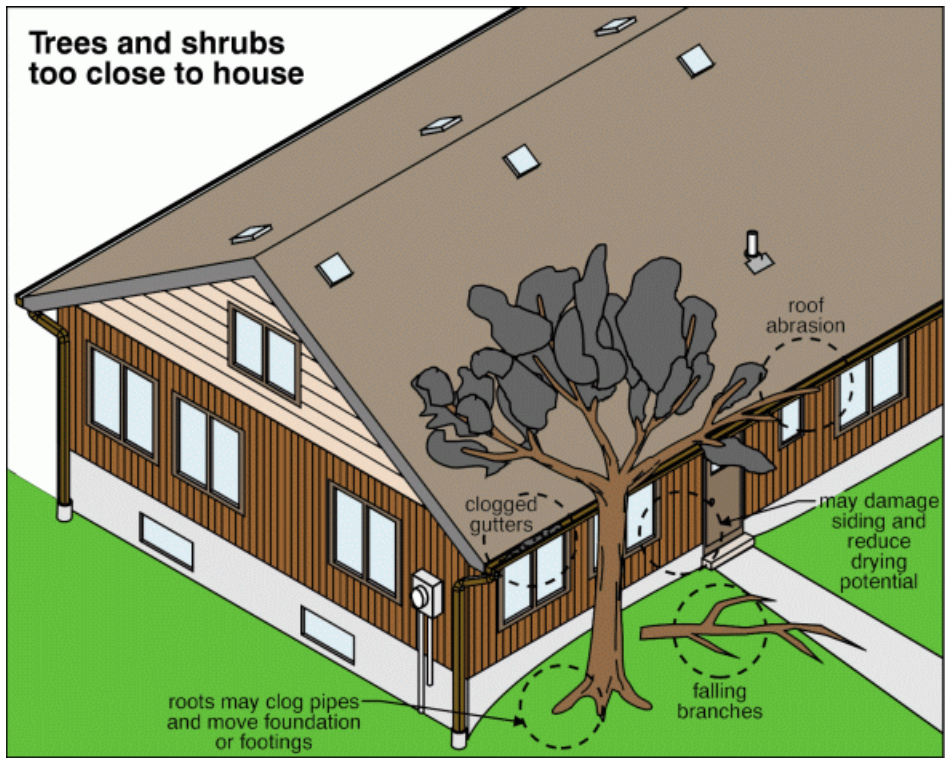
Condition: • [Trees or shrubs too close to building](#)

Several trees noted around home. Maintain these trimmed back so that branches do not contact roof or wall surfaces. Trees also can act as a conduit for vermin access to roof surface and possible entry. Have a qualified arborist check the health of large trees every few years.

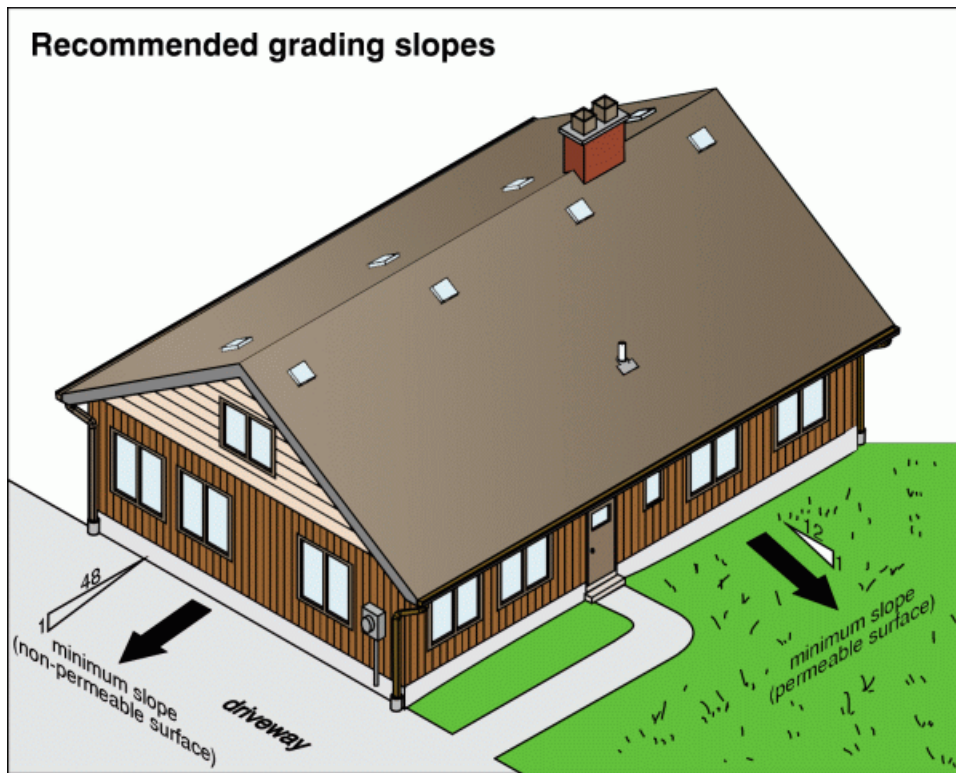
Condition: • [Improper slope or drainage](#)

Low areas at various sections around the house. A neutral or negative slope will hold moisture against the foundation and increase the possibility of water infiltration. Poor grading tends to pool water, creating a slip hazard in cold weather. Maintain a positive slope away from the house to help flush water away from the building. Low areas tend to pool water and keep it against the building making water infiltration more likely.

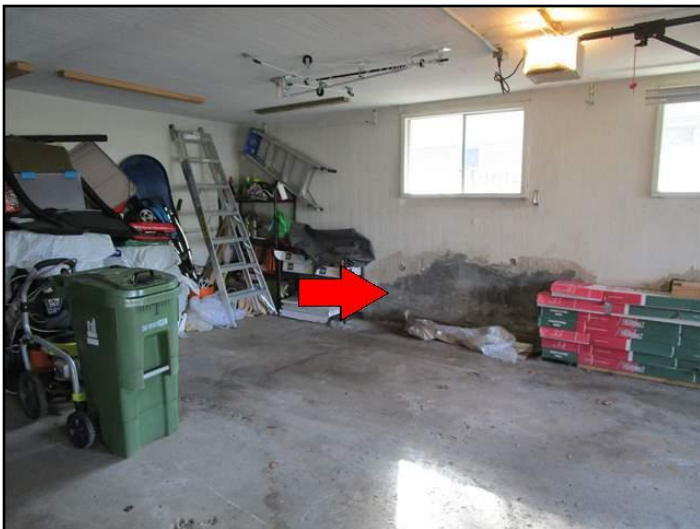
Condition: • Prior repairs noted to walls. White stains show water has entered brick. Ensure sprinkler heads are properly positioned to irrigate lawns/ gardens, and not building surfaces.

Prior repairs noted to walls...

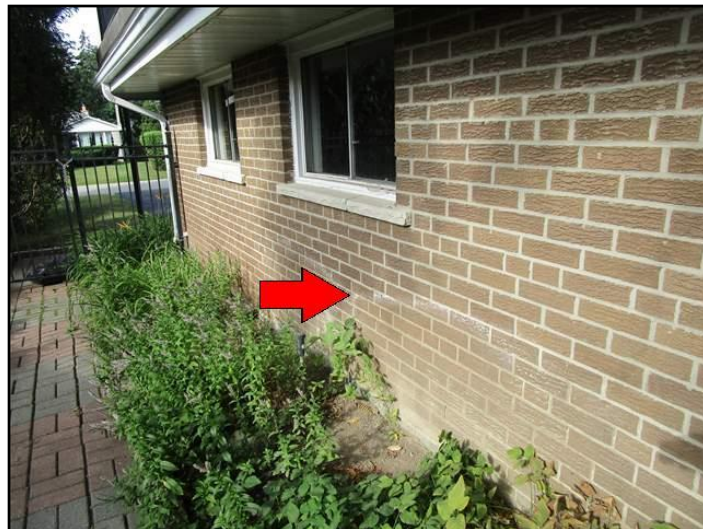
White stains show water has entered brick...

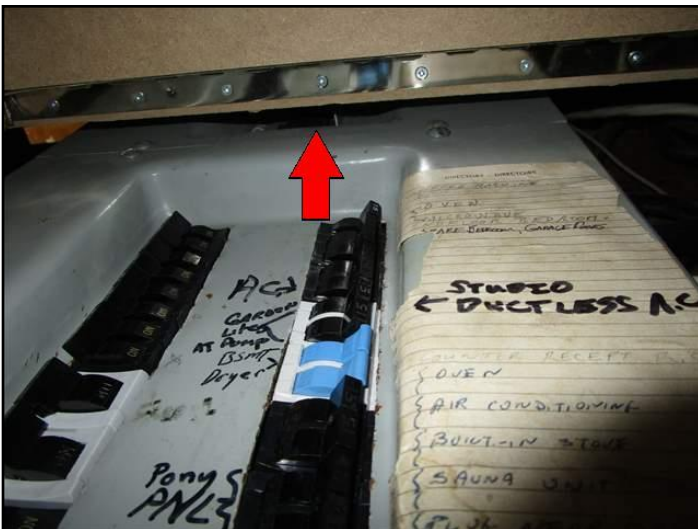
Condition: • [Poor access](#)

Service size not visible due to cabinetry. Appears to be 200amp service - verify.

Poor access to main disconnect

Task: Further evaluation

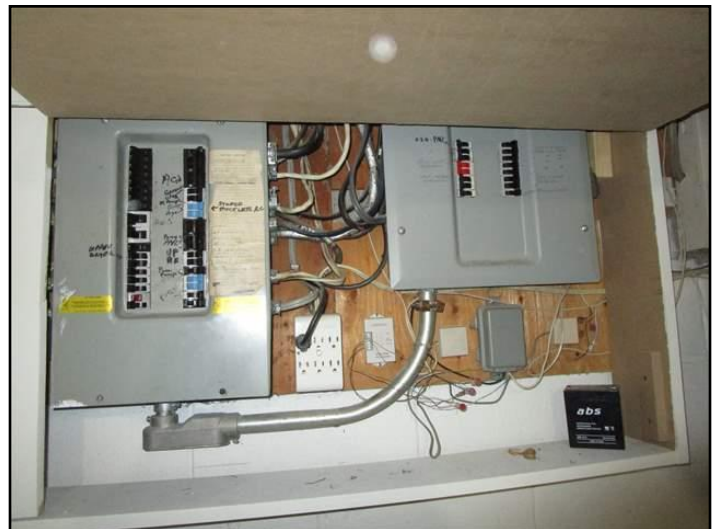
Panel covers not removed...

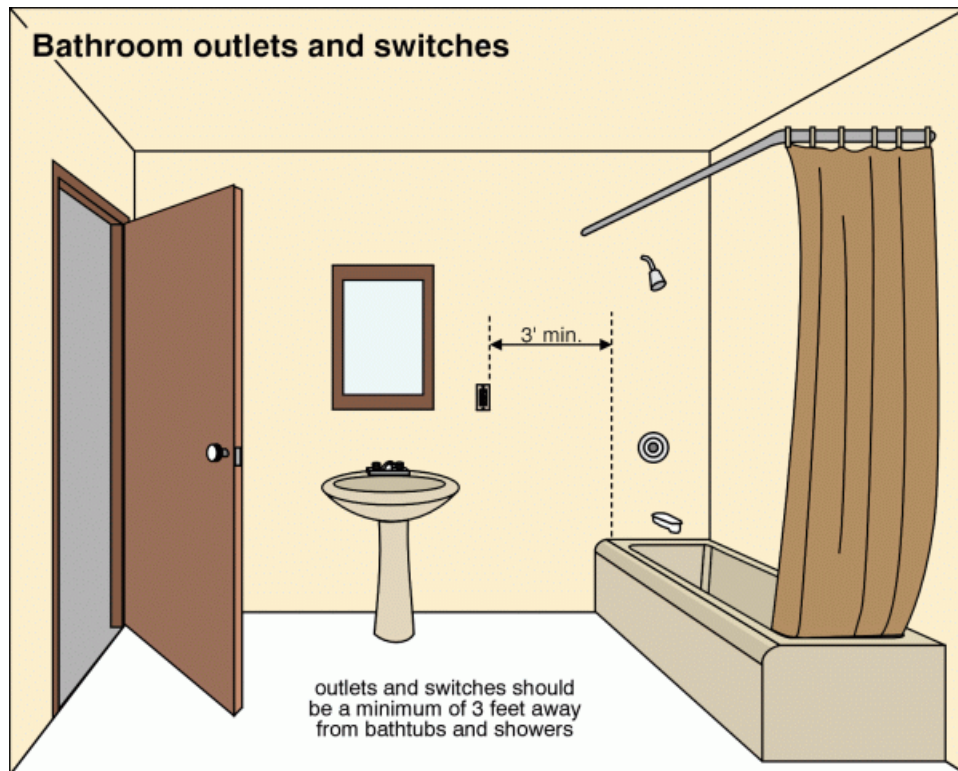
Location: Master Bathroom

Condition: • [Location poor \(near Bathtub or Shower Stall\)](#)

Task: Correct

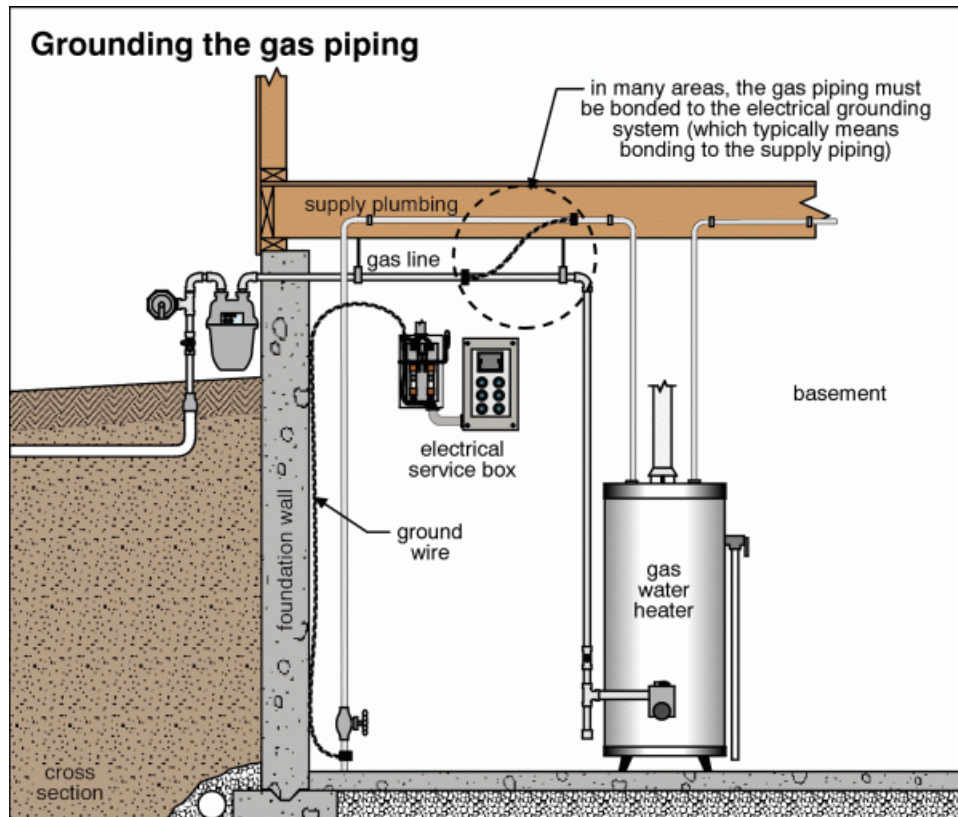
Location: Basement

Condition: • Piping not properly bonded

Bonding wire not visible to gas furnace or water heater.

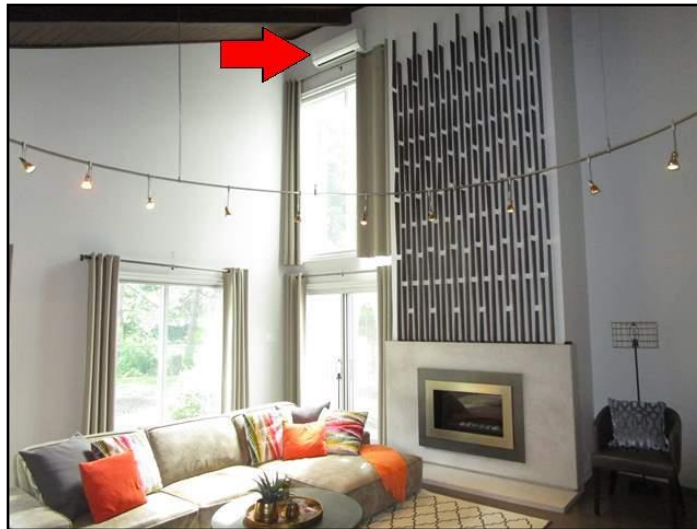
Location: Studio (Ductless Unit)

Condition: • [Inoperative](#)

Fan working at indoor unit but not cooling

Task: Seller to repair

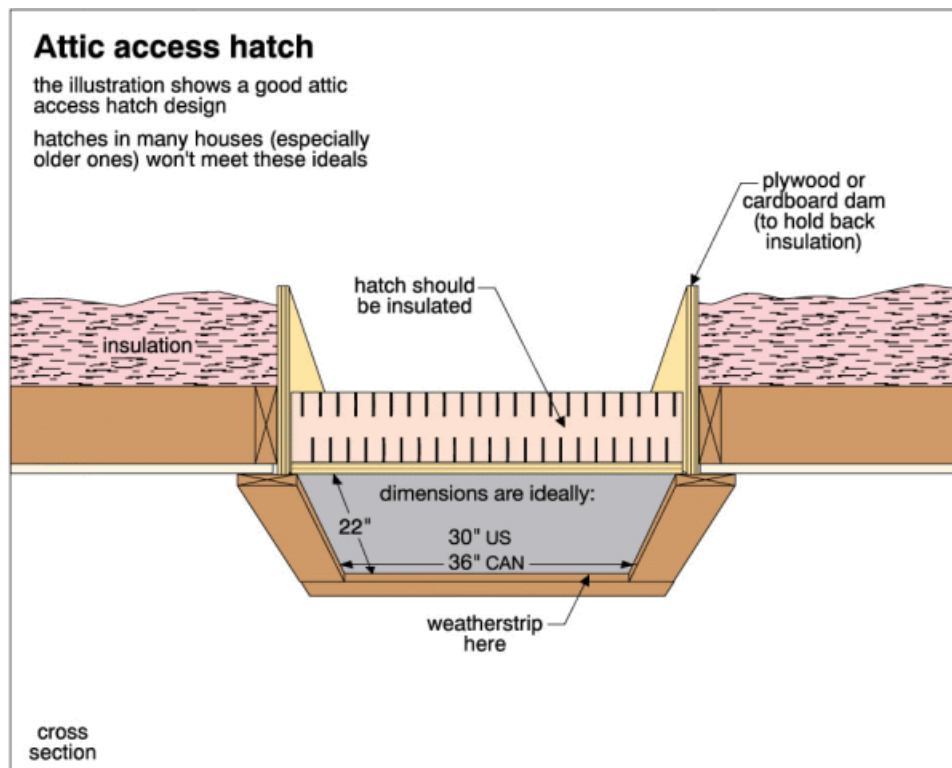
Condition: • Access Hatch: weatherstripping/fit less than ideal

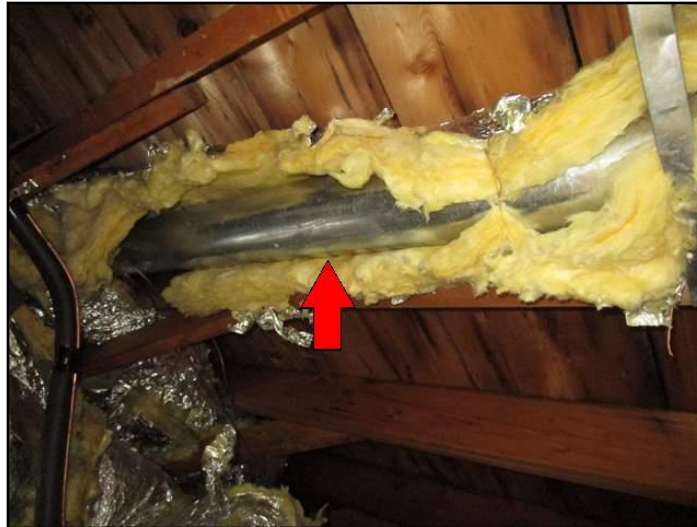
Condition: • [Not insulated in unconditioned space](#)

Not insulated in unconditioned space

Task: Repair

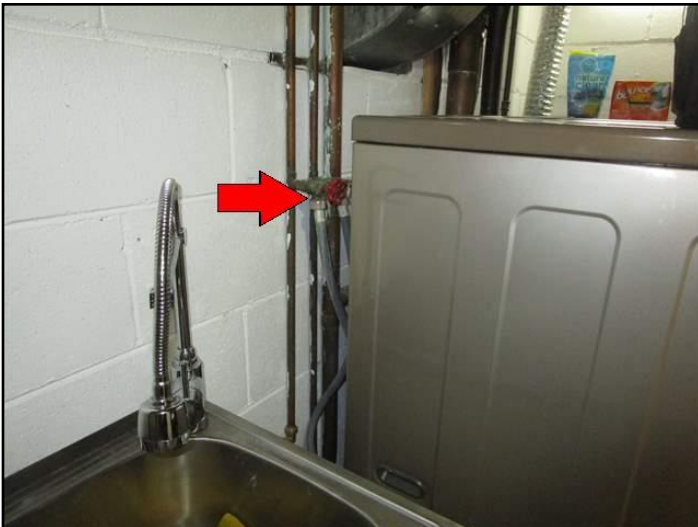
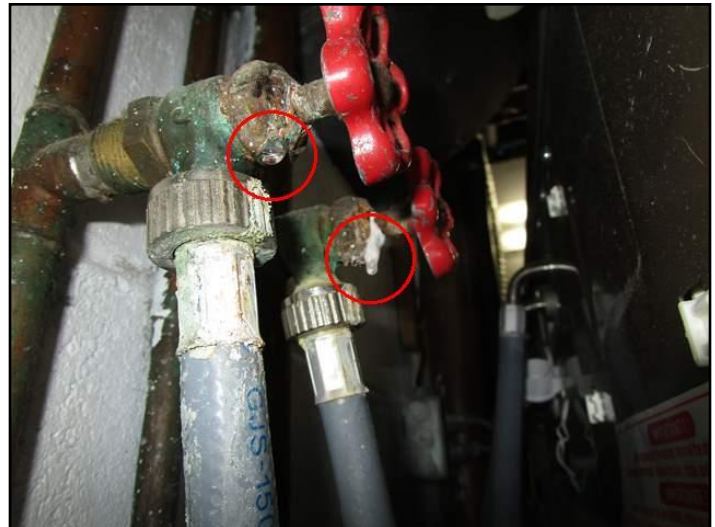
Condition: • [Leak](#)

Leak

Task: Repair

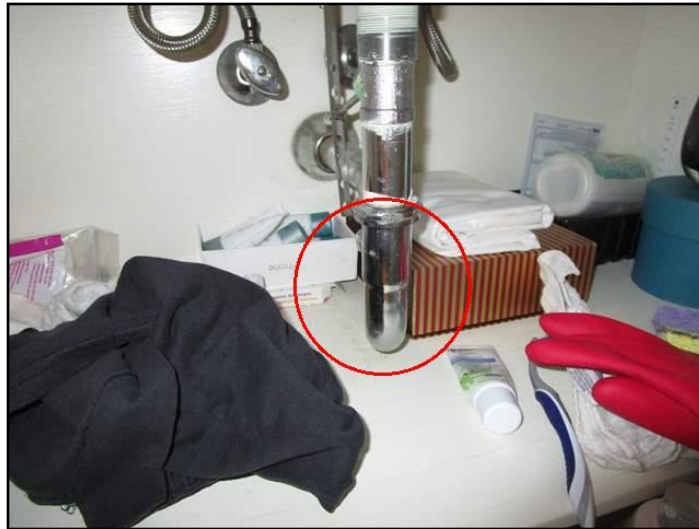
Condition: • 'P'-trap corroded.

'P'-trap corroded

Task: Replace

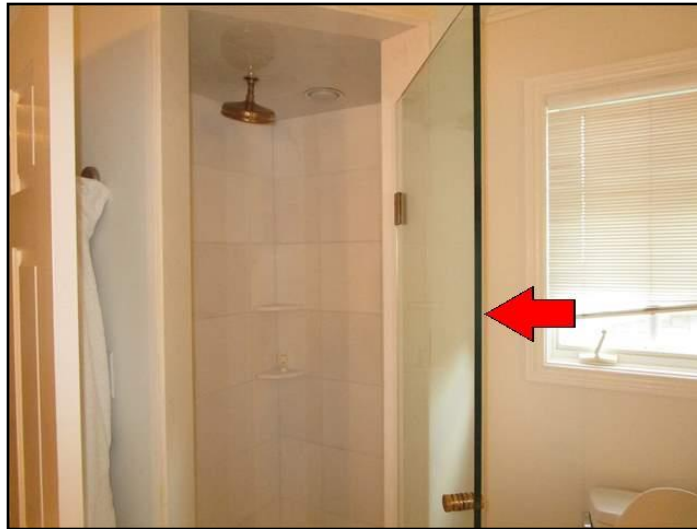
Condition: • The glass is not protected from striking the marble enclosure - the door could shatter if the impact is sufficient.

The glass is not protected from striking...

Task: Improve

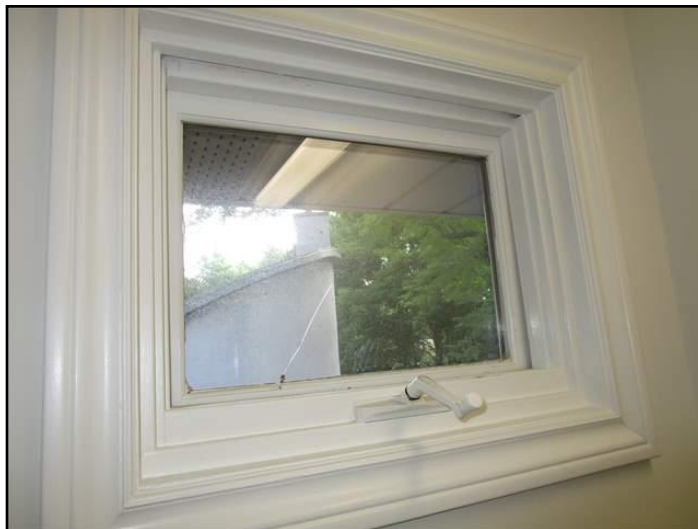
Location: Second Floor Laundry Room

Condition: • [Cracked](#)

Cracked

Task: Repair / Replace

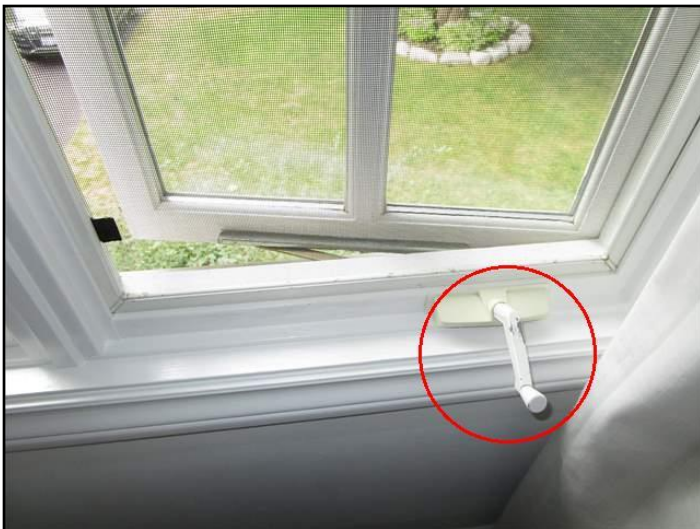
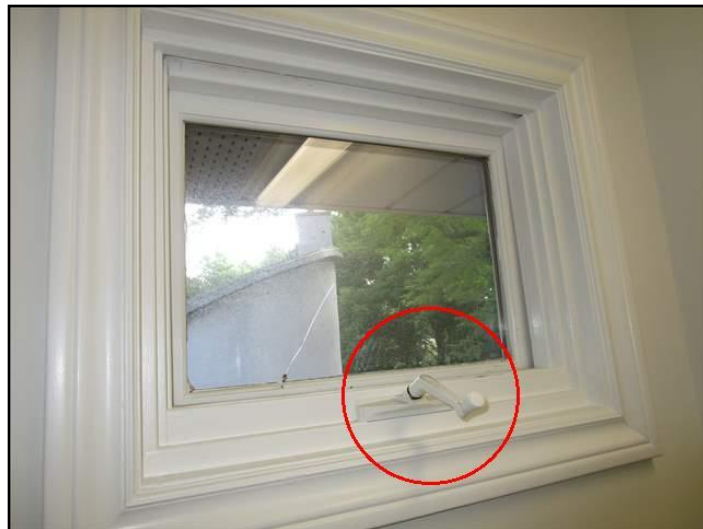
Location: For example, Center Second Floor Bedroom Laundry Room

Condition: • [Broken](#)

Operating mechanism(s) damaged.

Broken

Task: Repair

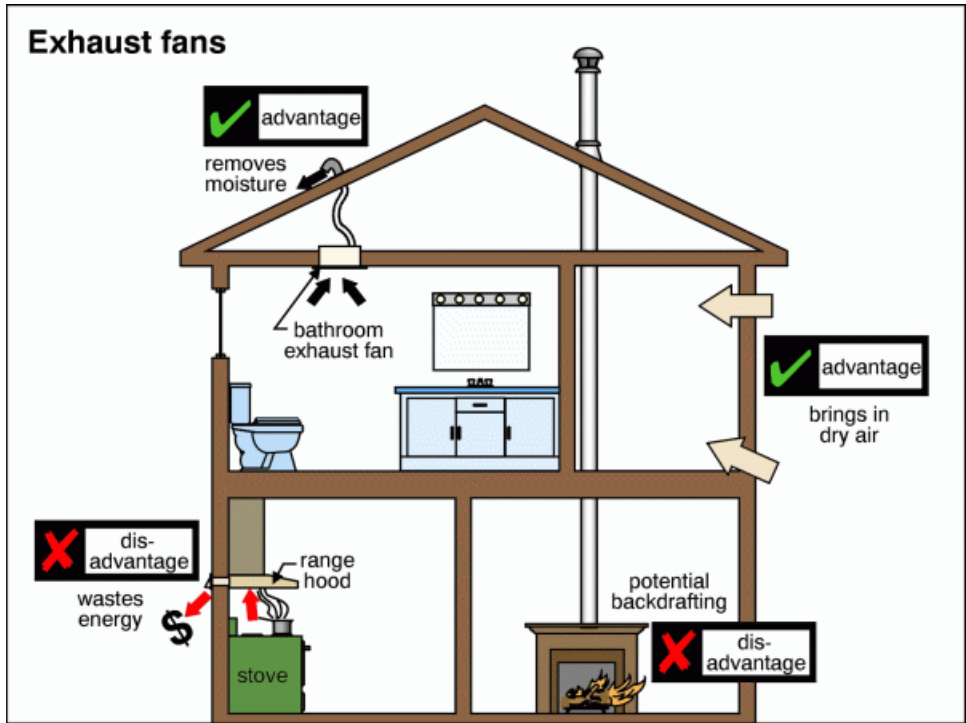
Location: Various For example, Second Floor Hallway Bathroom, Master Bathroom, Powder Room

Condition: • [Missing](#)

*Exhaust should discharge to exterior.

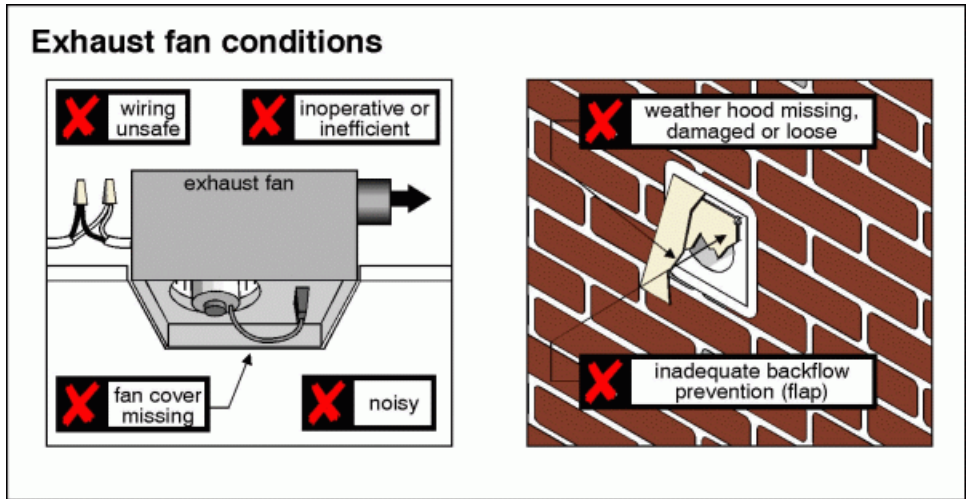
Location: East Exterior Wall Second Floor

Condition: • [Inadequate backflow prevention \(flap\)](#)

Task: Replace
