Your Inspection Report

25 Edgehill Rd Toronto, ON M9A 4N1

INSPECTION DATE: Thursday, June 14, 2018

RE: Report No. 62927 25 Edgehill Rd Toronto, ON M9A 4N1

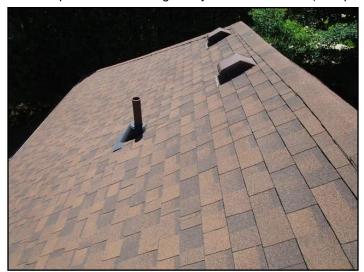
Condition: • Roof coverings wear out and are replaced every 15 years or more, depending on a number of variables. An annual roof tune-up by a qualified roofer is strongly recommended.

Seller reports roof covering newly installed in 2017 (except the upper flat roof area). Ask for any warranty information.

Roof coverings wear out and are replaced...

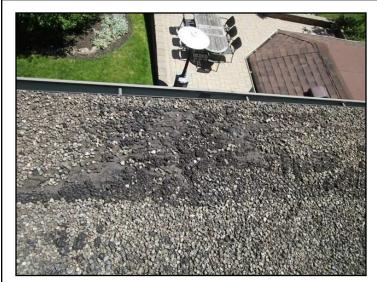
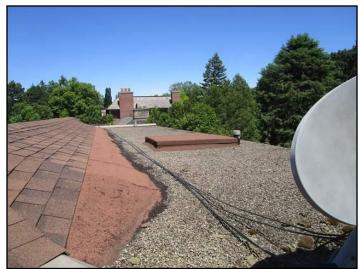
Condition: • Aging

The built-up roofing material is near the end of its life expectancy. Roof coverings of this type are usually an older installation. No visible evidence of leaks noted underneath. Inspect annually.

Aging Aging

Task: Replace
Time: Unpredictable
Cost: \$5,000 - \$10,000

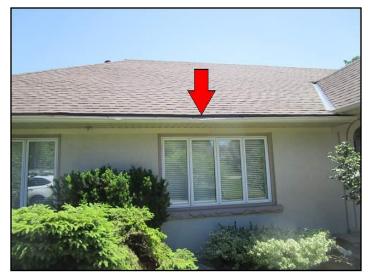
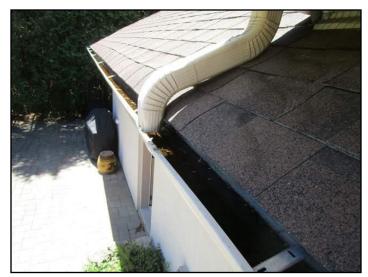
Condition: • Improper slope, ponding

Improper slope, ponding

Task: Repair

Time: As soon as practical

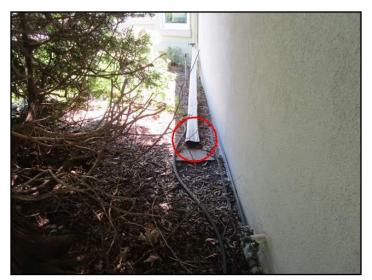
Condition: • Discharge too close to building

Downspouts should discharge at lest 6 feet from foundation walls.

Discharge too close to building

Time: As soon as possible

Cost: Minor

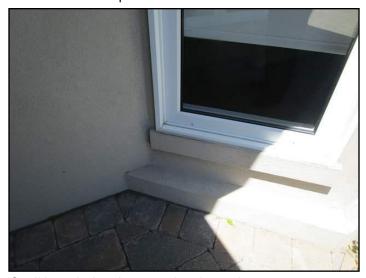
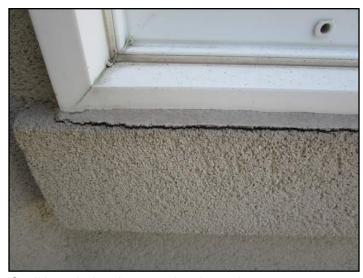
Condition: • Caulking missing, loose or deteriorated

Water can enter where sealant is missing or has deteriorated and damage area(s) behind.

Caulking missing, loose or deteriorated

Location: Various **Task**: Protect

Time: As soon as practical

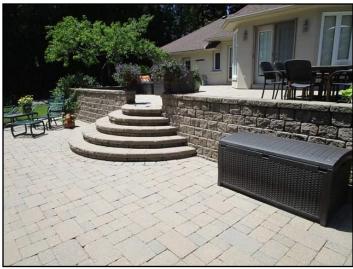
Condition: • Missing Location: East Patio

Missing

Task: Provide

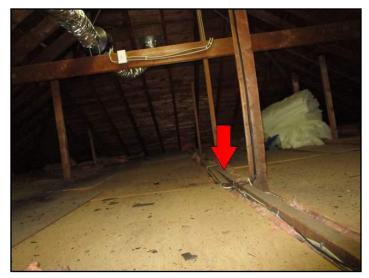
Condition: • <u>Sagging</u> Location: Garage Attic

Sagging

Task: Repair

Time: As soon as practical

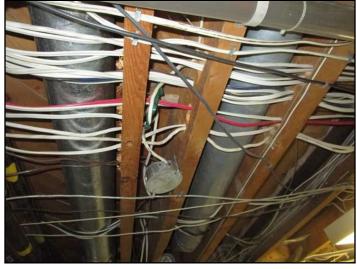
Condition: • Too close to ducts, pipe, chimneys, etc.

Too close to ducts

> Wire clearances from hot ducts and pipes a piece of insulation can be used to separate the duct or pipe from the wire

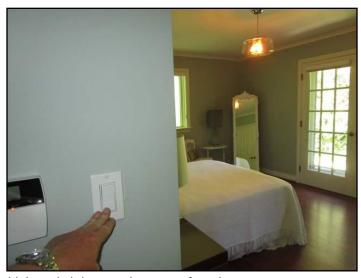
Condition: • Light switch inoperative or not found.

Location: Northeast First Floor Bedroom

Light switch inoperative or not found

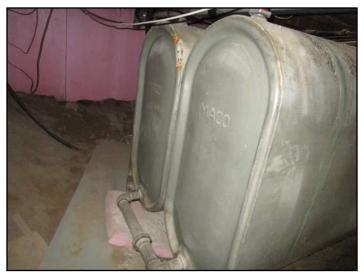
Condition: • Abandoned oil tanks.

Abandoned oil tanks

Task: Remove

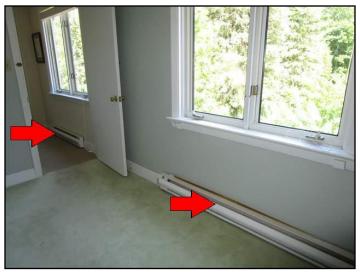
Condition: • Inoperative heaters

Inoperative heaters

Task: Further evaluation / Repair

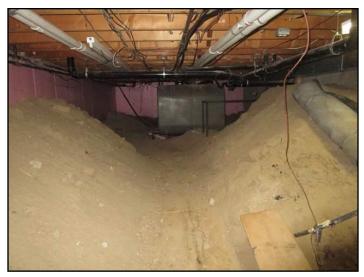
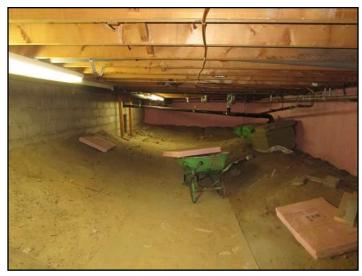
Condition: • No vapor barrier

Excess moisture from ground may enter home here. Plastic should be sealed against the perimeter of the crawlspace to help prevent moisture/dampness from entering home through dirt floor.

No vapor barrier

Task: Provide

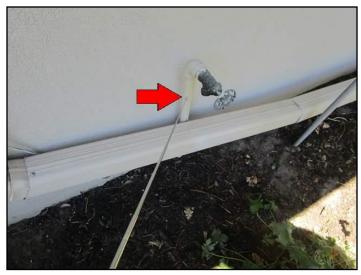
Condition: • Galvanized steel

Minor amount of steel piping material found. There may be more of this type of supply pipe in the building. Consult a qualified professional for further evaluation.

Location: For example, East Exterior Wall

Galvanized steel

Task: Replace **Time**: Unpredictable

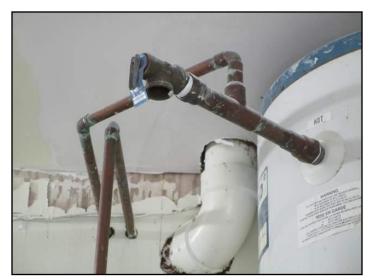
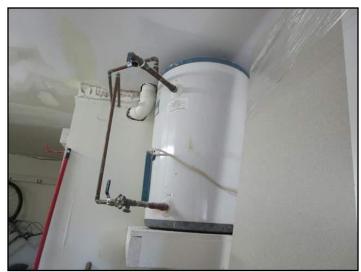
Condition: • Discharge tube missing

Location: Pool House

Discharge tube missing

Task: Provide **Time**: Immediate

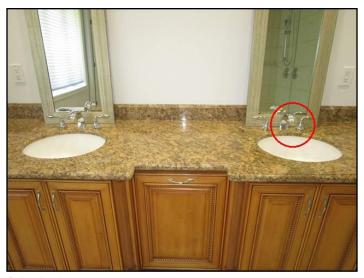
Condition: • Drip, leak

Location: Right Side Master Bathroom Basin

Drip, leak

Task: Repair

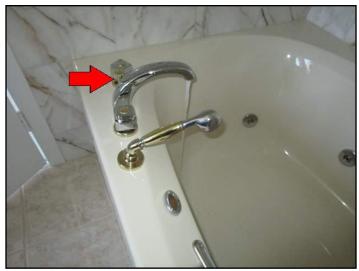
Condition: • Shower diverter inoperative or defective

Diverter stiff/difficult to operate. **Location**: Second Floor Whirlpool

Diverter stiff/difficult to operate

Task: Repair / Replace
