Your Inspection Report

250 Annette St
Toronto, ON

INSPECTION DATE:
Friday, October 18, 2019

RE: Report No. 69815
250 Annette St
Toronto, ON

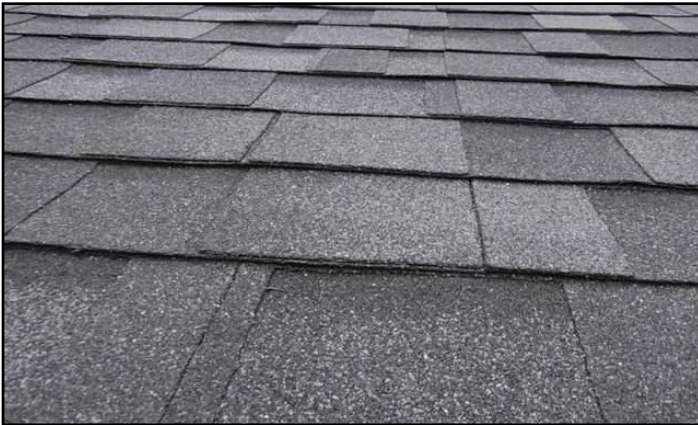
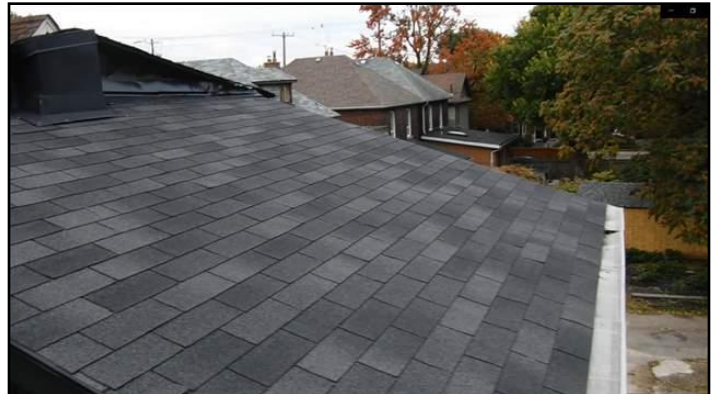
Condition: • Roof coverings wear out and are replaced every 15 years or more, depending on a number of variables. An annual roof tune-up by a qualified roofer is strongly recommended.

*Different roof ages noted. While the north additions have shingles that are newer, the main house shingles appear to be within the last half of their normal life expectancy. A few more years of service are expected from this roof covering, although some maintenance may be required to help extend their useful life.

Roof coverings wear out and are replaced...

Task: Inspect annually

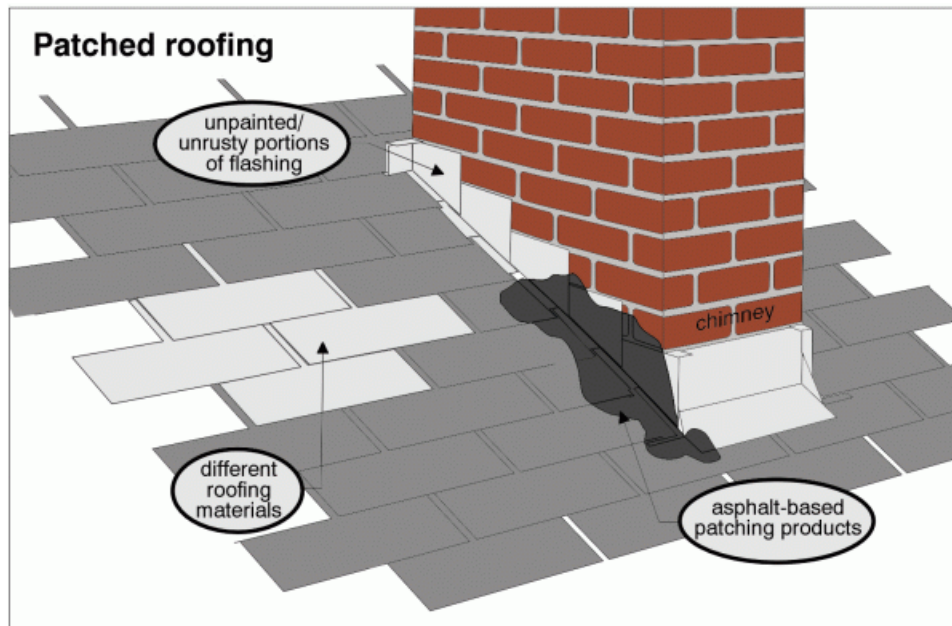
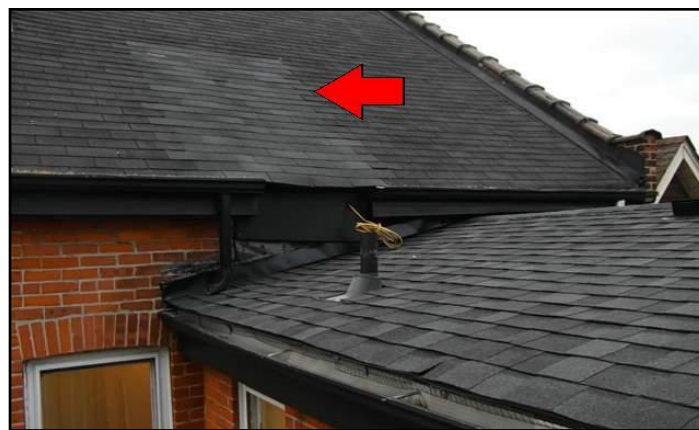
Patched

*Prior repairs noted. Nail heads exposed - potential leak. A dab of sealant overtop the nail head(s) would help reduce the risk of moisture infiltration. (No visible evidence of staining/moisture entry noted).

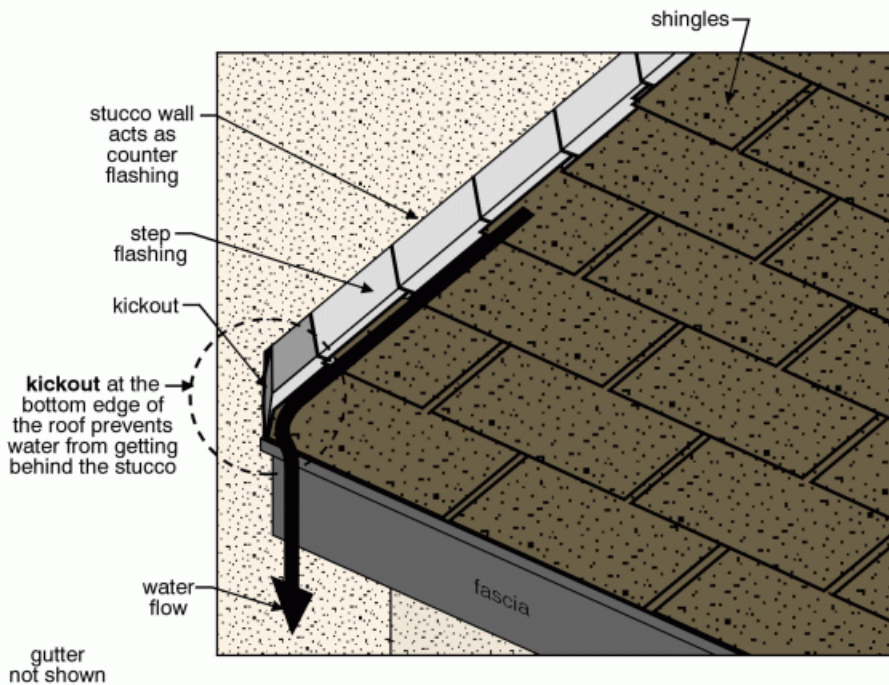
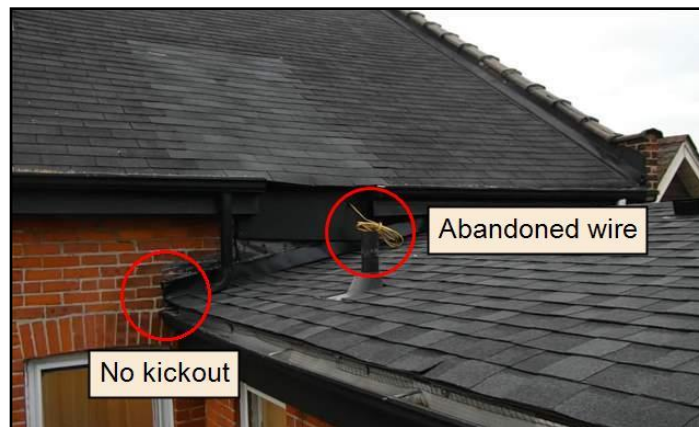
Kickout flashing - missing

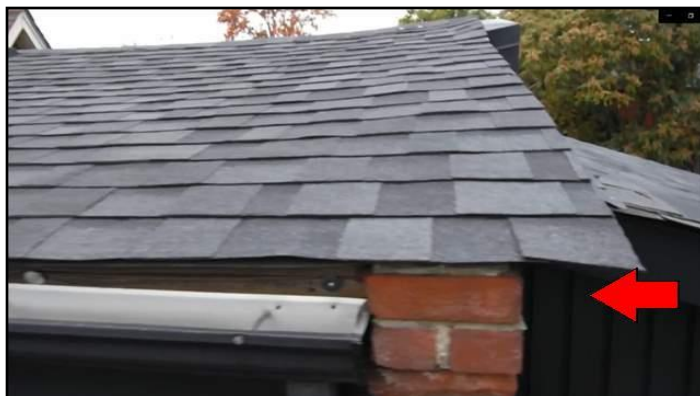
Location: Northeast

Condition: • Missing gutter section.

Missing gutter section

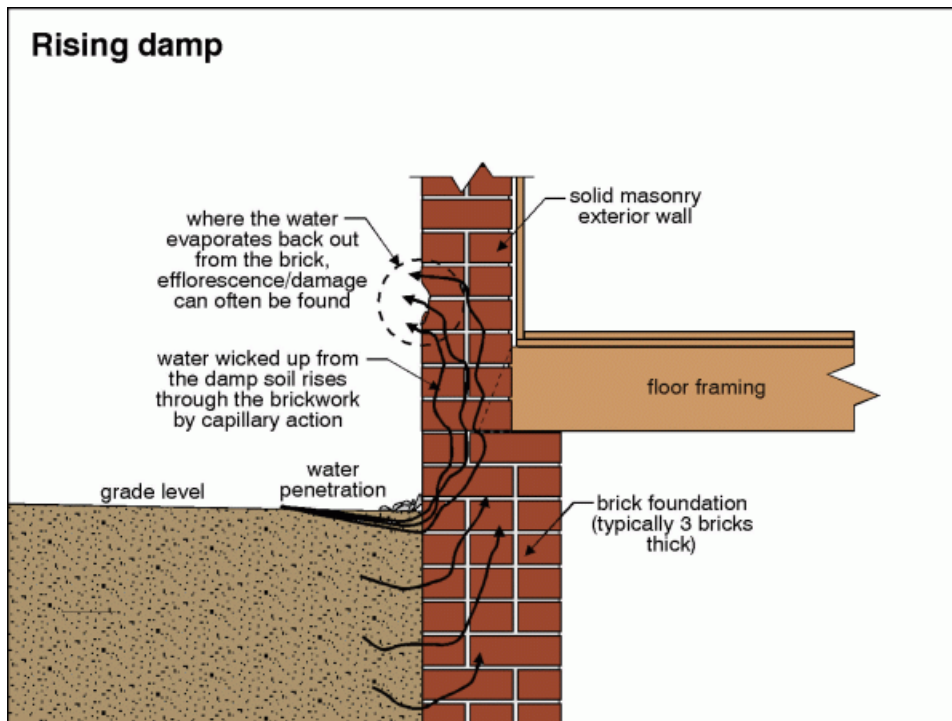
Location: For example, Southwest

Mortar/masonry deterioration. Not unusual for this vintage of home. Damage likely due to snow build-up against wall.

One of the most common types of masonry repair is "tuckpointing"--fixing major holes/cracks in the mortar joints between bricks. Mortar around brick pulls water out from the bricks and helps to dry them out. Missing or cracked mortar can mean bricks hold water longer and thus they can decay faster. Mortar usually deteriorates first, then the bricks after that.

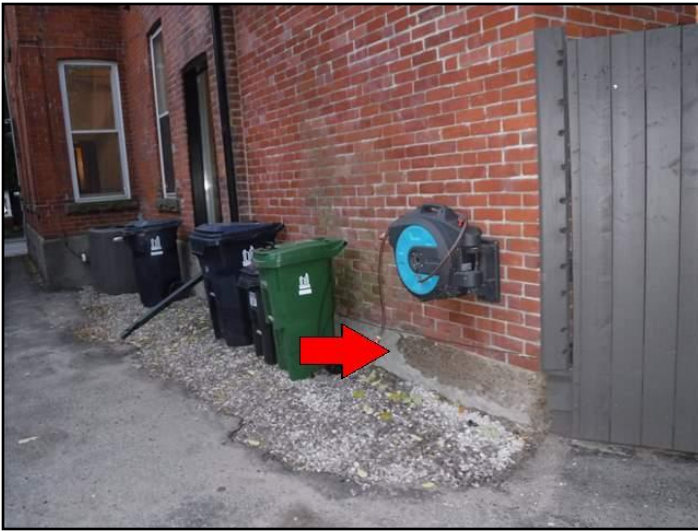
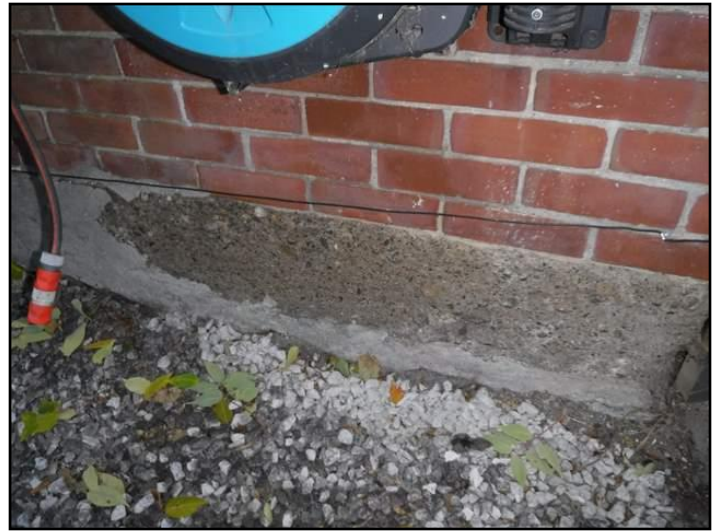
Loose/hollow sounding areas.

Parging damaged or missing

Task: Repair

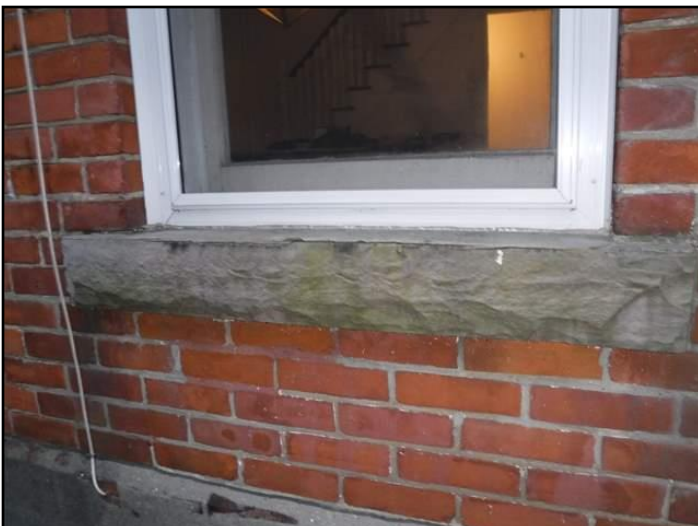
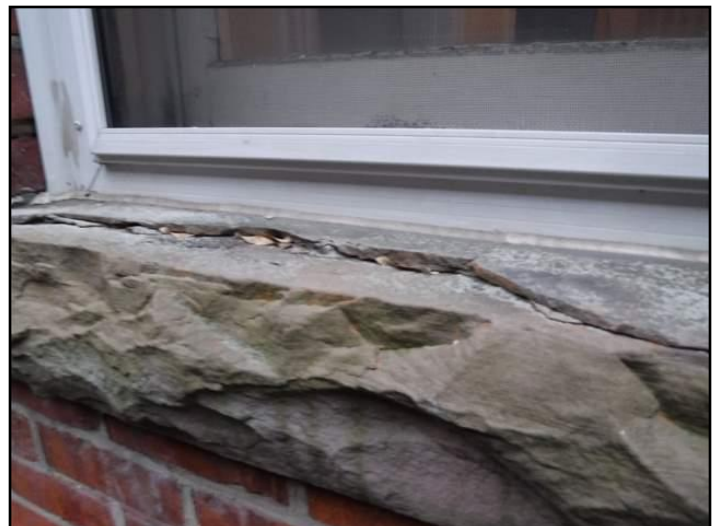
Damaged, deteriorated sills.

*Water can enter where mortar/masonry is missing or has deteriorated and damage area behind. Regularly check at sills, around door areas and any other wall openings as well.

Example: Sill deteriorated

Seal gaps/ cracks to help keep moisture out and to help prevent further damage.

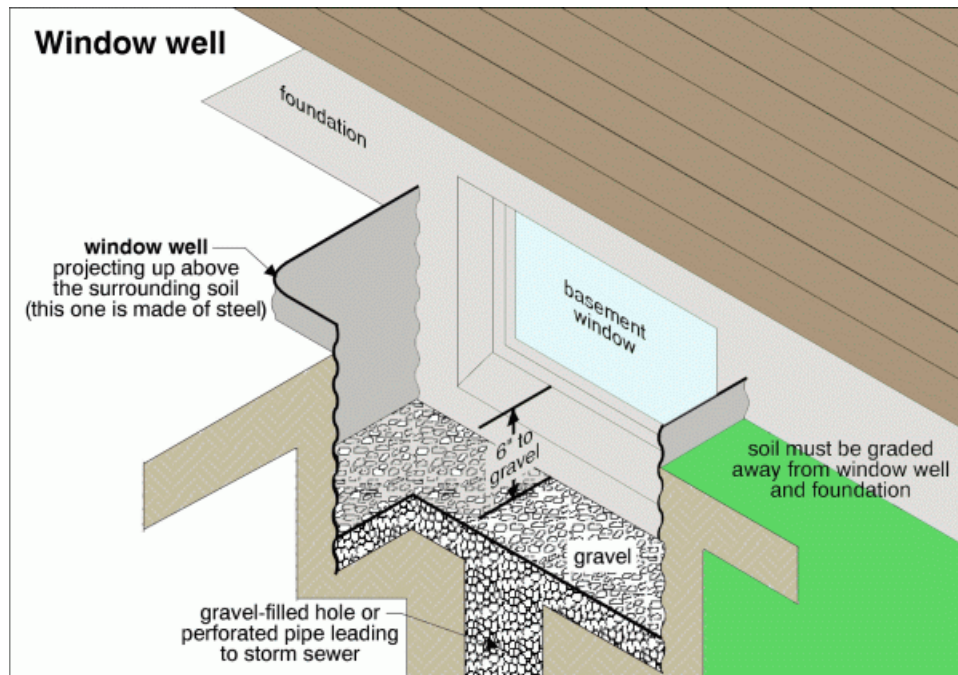
Location: East

Condition: • [Missing](#)

Keep area(s) properly sloped away from foundation wall(s) and clear of snow and debris to help prevent water infiltration.

*Cost of installing a proper window well- \$1,000 and up each.

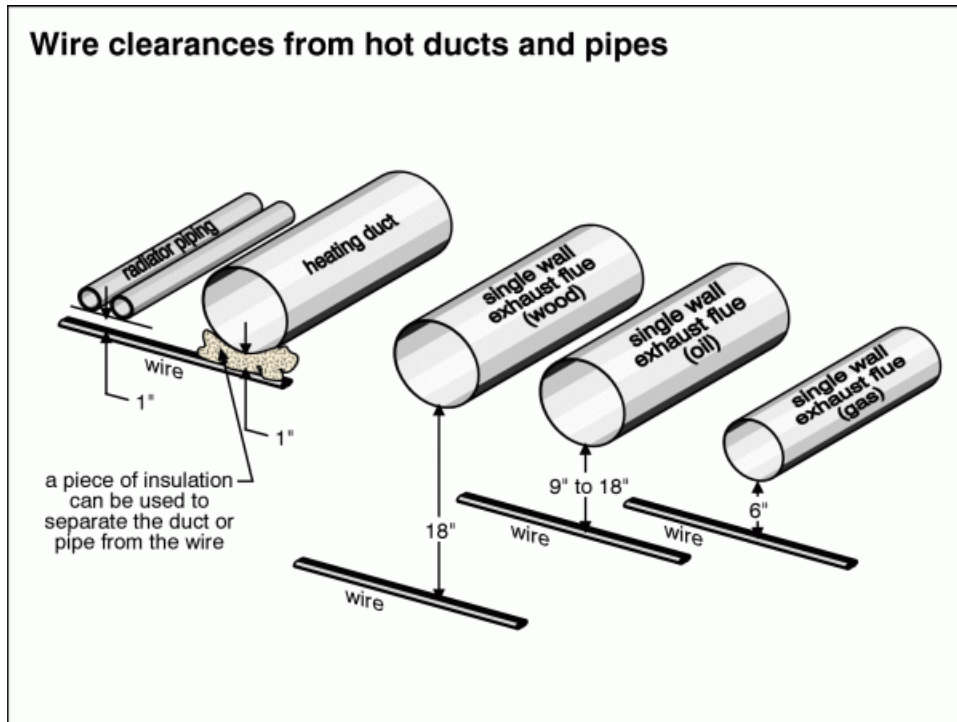
Location: Various Basement

Condition: • [Too close to duct, pipe, vent or chimney](#)

Task: Protect

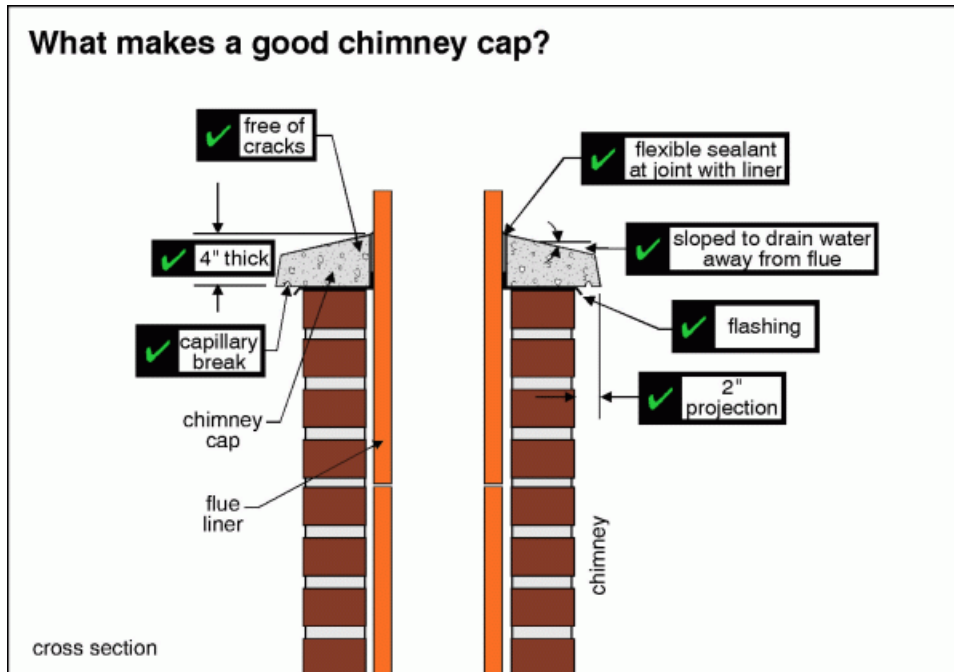
Condition: • Chimney cap missing

Task: Provide

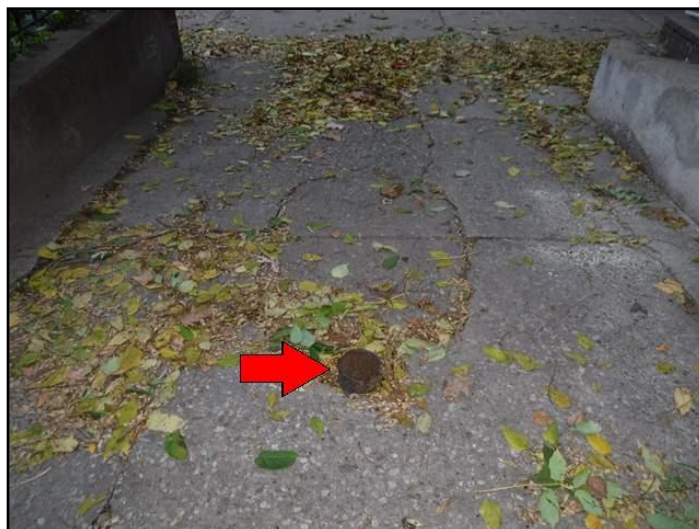
Condition: • Clean out sits proud at driveway. Cap missing - debris noted within.

Clean out sits proud at driveway...

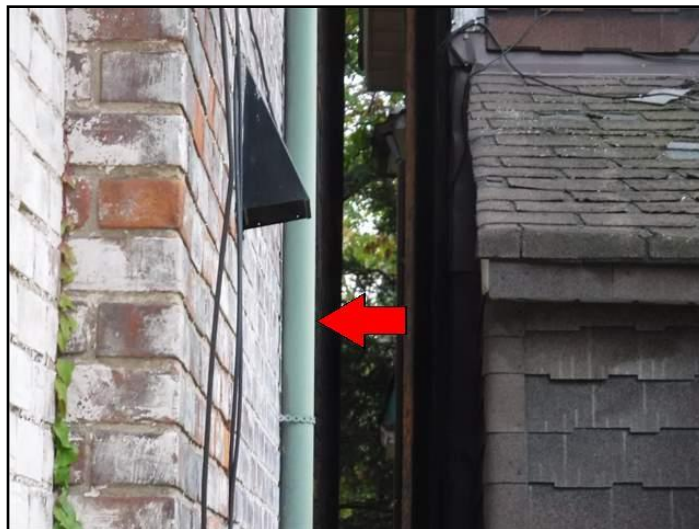
Condition: • Height above roof excessive (risk of frost closure)

Excess waste pipe exposure at exterior wall

Task: Monitor / Repair

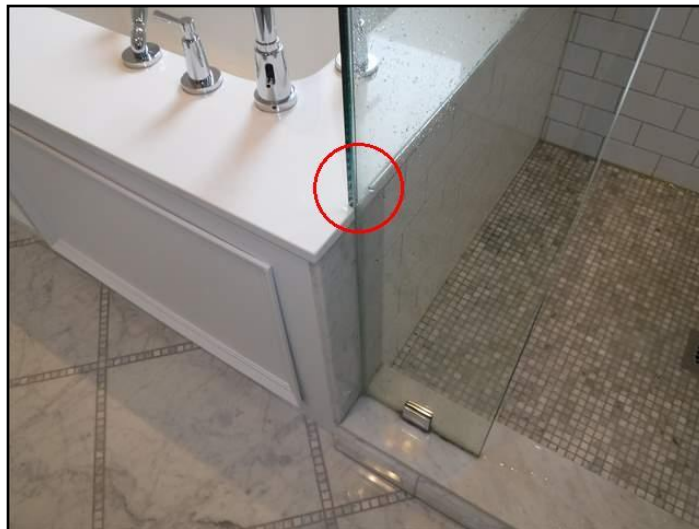
Location: Second Floor Bathroom

Condition: • [Leak](#)

Leak

Task: Seal

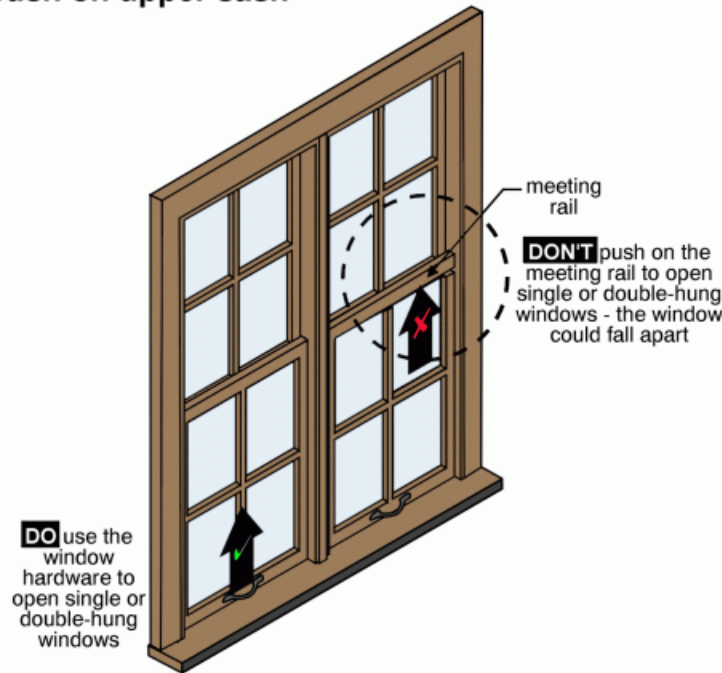
*Various windows painted shut.

Don't push on upper sash

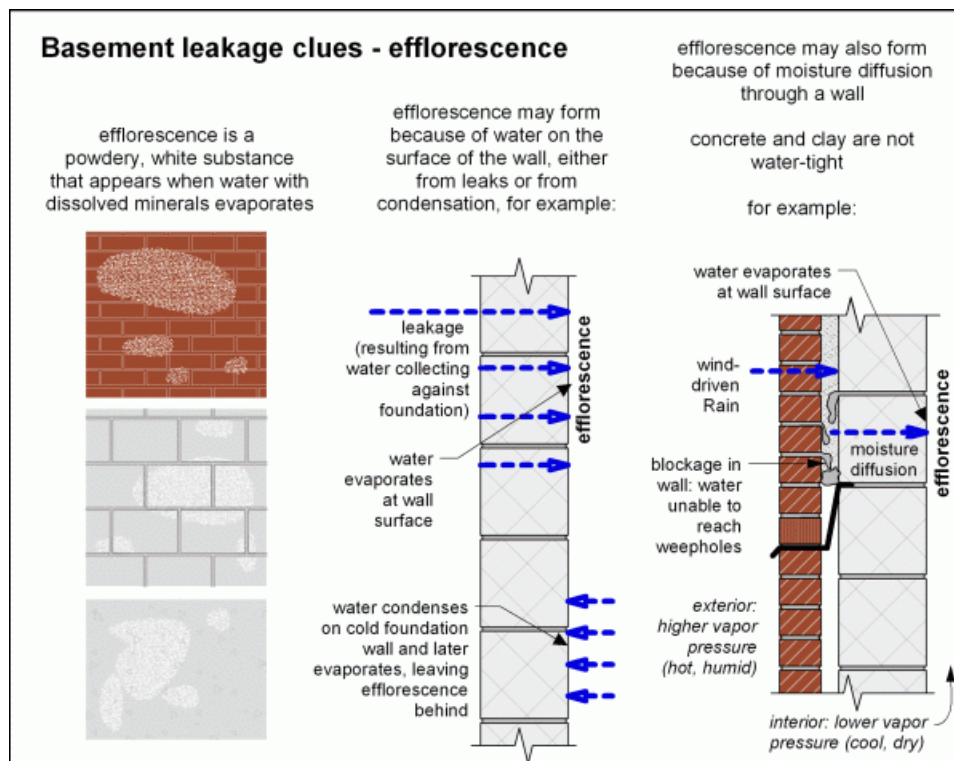
Condition: • [Efflorescence](#)

Follow the steps in this section to systematically improve the exterior as best possible to divert as much moisture as possible away from the house. Cost will increase as you proceed down the list. Generally speaking, controlling your downspouts and providing improved grading will offer the most benefit for the least cost. See other comments in Exterior and Interior sections for best strategies to minimize the potential for future water problems in the basement. A dehumidifier is also advised (especially for the summer).

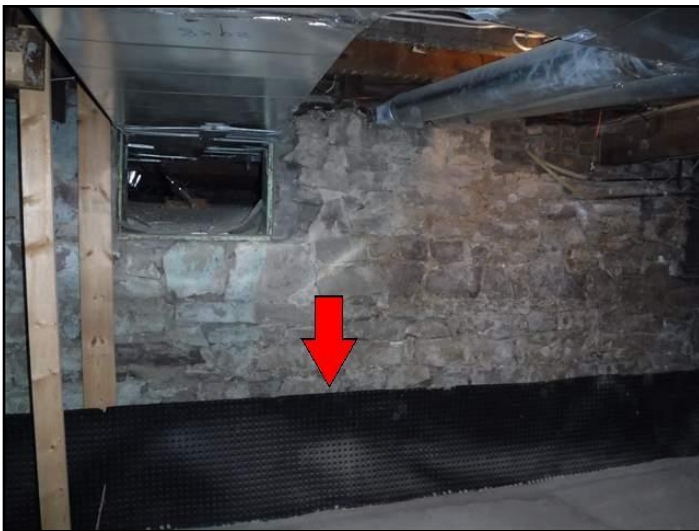
Interior drainage system noted

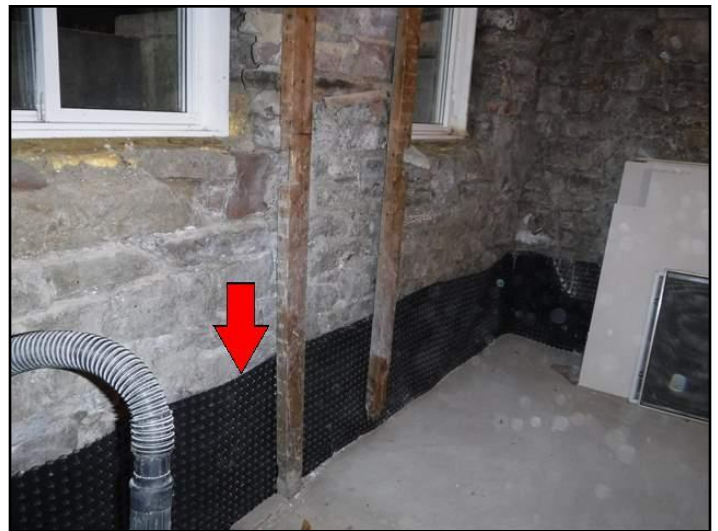
New dampproofing material
