Your Inspection Report

PREPARED FOR: ANA SANTOS

INSPECTION DATE: Friday, January 31, 2020

RE: Report No. 70872 1291 Royal York Rd, 6 Toronto, ON M9A 5E6

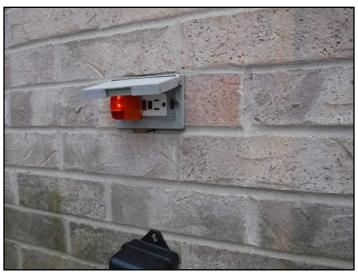
Condition: • Test faulty on GFCI/GFI (Ground Fault Circuit Interrupter)

*Did not trip when checked with a hand-held tester.

Location: North Deck

Test faulty on GFCI/GFI (Ground Fault...

Task: Repair

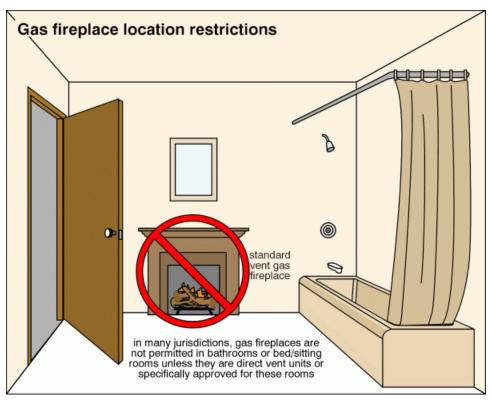
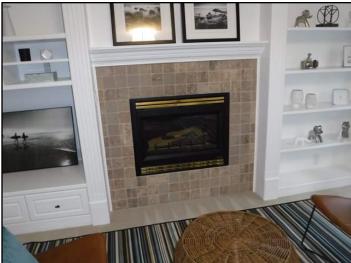
Condition: • Not suitable for use in a bedroom or bathroom

*Fireplaces in bedrooms need to be specially designated for that use. A data plate that reads "Approved for use in bedrooms" - or similar was not found/visible.

Location: Second Floor Bedroom

Fireplaces in bedrooms need...

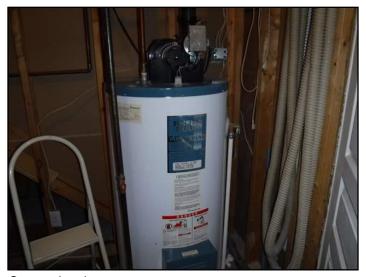
Conventional

Water heater approximate age: • 23 years

Condition: • Near end of life expectancy

Some insurance companies ask that the unit be replaced due to its age and because the basement is finished. The goal is to prevent water damage due to tank failure.

Task: Replace

Time: Unknown, unless insurance company requires that it be replaced immediately

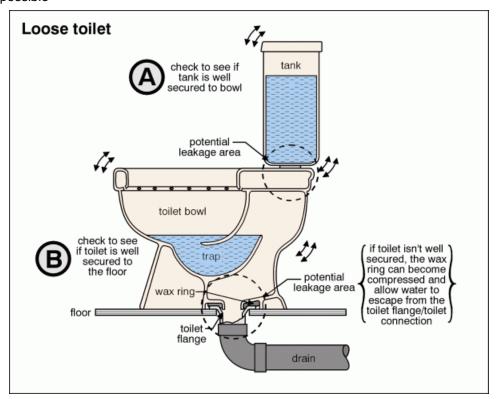
Condition: • Loose

Location: Third Floor Bathroom

Task: Secure

Time: As soon as possible

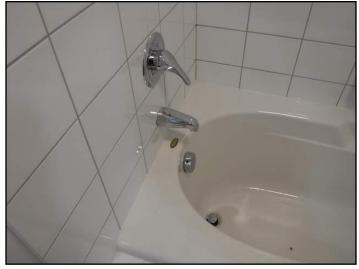
Third floor bathtub not tested - water off.

Bathtub not tested

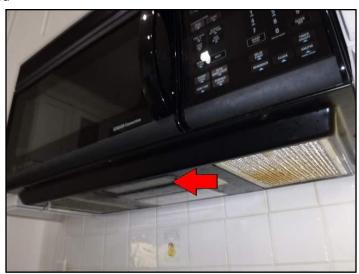
Condition: • Work light inoperative. **Location**: Kitchen Range Hood

Work light inoperative

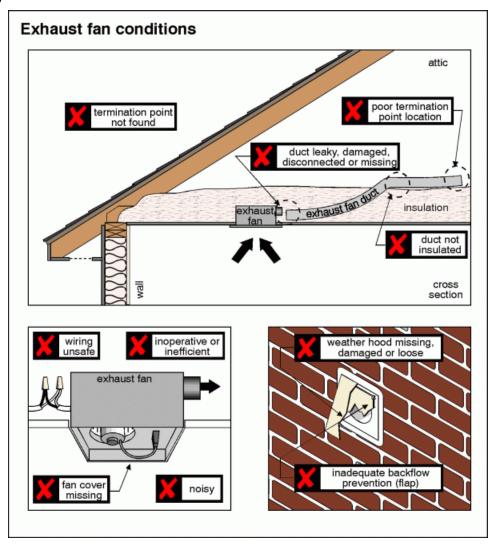
Condition: • Noisy

Fans may be near the end of their normal life expectancies.

Location: For example, Second Floor Ensuite Bathroom, Third Floor Bathroom

Task: Replace

Time: When necessary Cost: Minor (each)

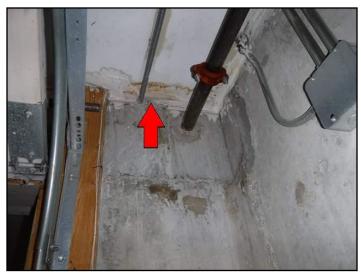
Condition: • Water stains beside vehicle door. Higher than average moisture readings noted.

Water stains beside vehicle door...

Task: Further evaluation / Repair

Time: If necessary
