1559 Islington Ave Toronto, ON M9A 3M4

INSPECTION DATE: Wednesday, July 7, 2021

RE: Report No. 78037, v.2 1559 Islington Ave Toronto, ON M9A 3M4

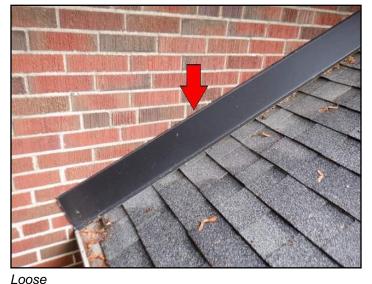
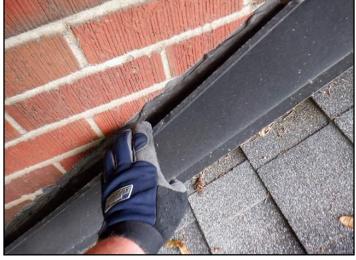
Condition: • Loose *Not sealed properly at top. Kick-out flashing missing at bottom. Location: Front Above Entrance Task: Secure / Seal Time: As soon as practical Cost: Minor

Loose

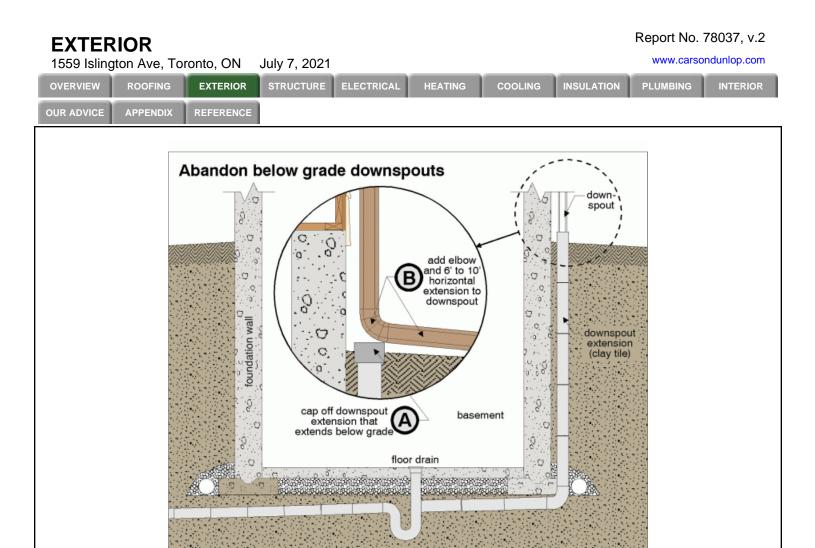
Condition: • Downspouts that discharge below grade may leak or be clogged, resulting in water in the basement or crawlspace.

While the current arrangement is convenient and a good method to deal with rain water, if the drain pipe becomes clogged and/or deteriorated, there is a greater risk of water backing up and leaking into the basement. Note: On newer houses the drain may go into the weeping tile (not the floor drain).

Task: Re-direct downspouts to discharge above grade at least 6 feet from home.

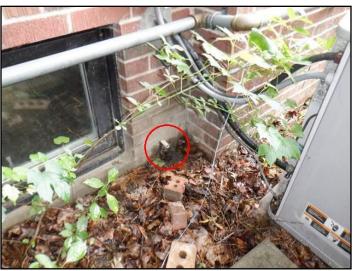
Condition: • Condensate discharge to close to wall. **Location**: Right Side (near air conditioner)

cross section

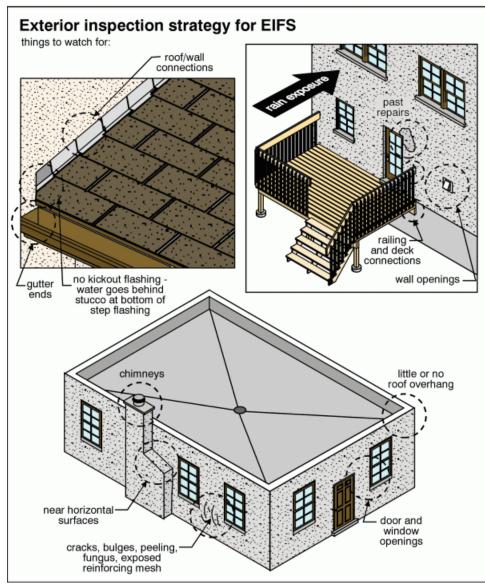
Condition: • This type of siding system is susceptible to damage if there are cracks or gaps that allow water penetration into the wall assembly.

Task: Provide annual inspections and repairs as needed. Focus on intersections, penetrations, joints and horizontal surfaces. Watch for anywhere moisture may collect or enter the wall assembly.

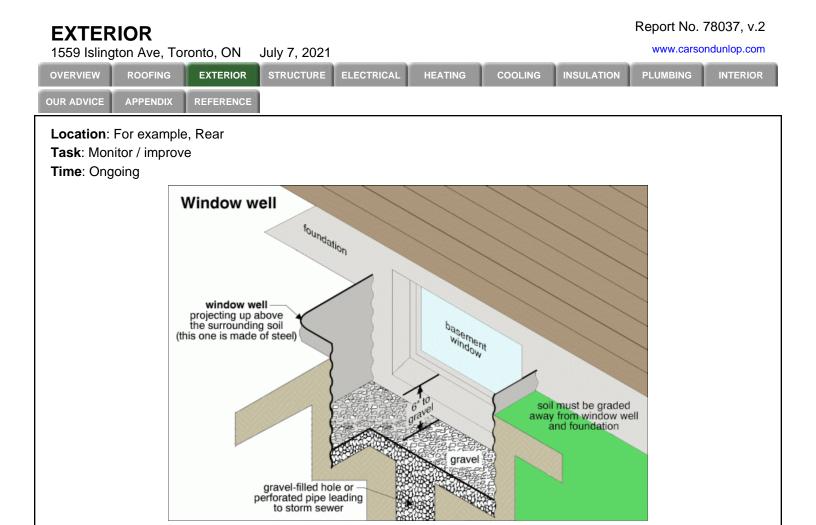
Condition: • Missing

This is typical for this type and age of home. As a minimum, clean snow from in front of window (in winter) to prevent water entering system.

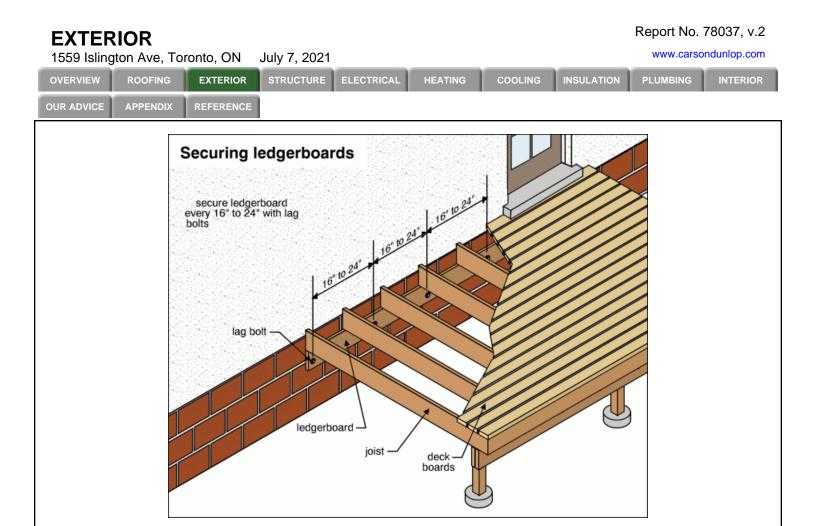
Condition: • The quality of the connection of a deck to the building is a common issue. This cannot be verified during a home inspection, but you should understand this is a potential weak spot in any deck system. **Task**: Inspect annually

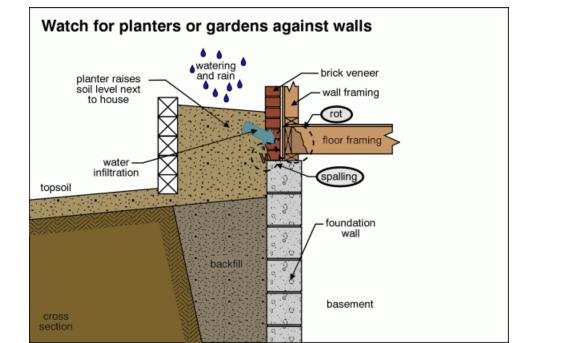
Condition: • Flagstone requires extra maintenance at mortar areas. In cold weather, water that penetrates cracks or missing/damaged mortar will freeze and expand causing increased damage to the walk, porch and step areas. **Location**: For example, Front Porch

Condition: • Raised gardens against the house

*Because gardens tend to see water more frequently, these could be areas where moisture could enter the basement area. If basement leakage becomes an issue, relocation of the garden(s) may be necessary.

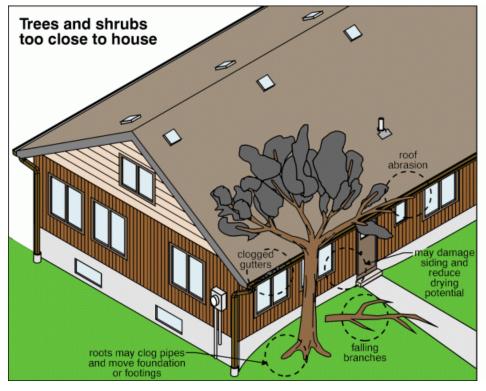
Condition: • Shrubs/Trees - too close to building (trimming needed)

*Mature shrubs/trees noted. Branches should be maintained so that they do not contact roof or wall surfaces. Time: Regular maintenance

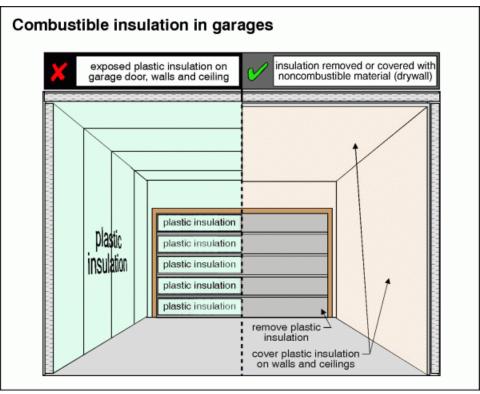
Condition: • Exposed combustible insulation

Task: Protect

Time: As soon as possible

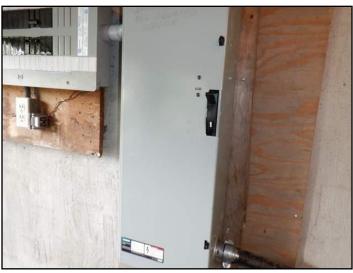
• Fuses - garage

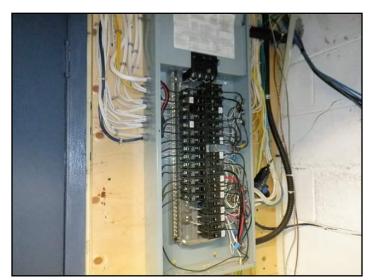
Breakers - basement

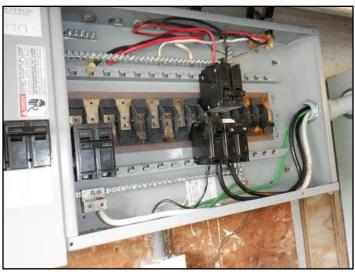
Breakers - garage

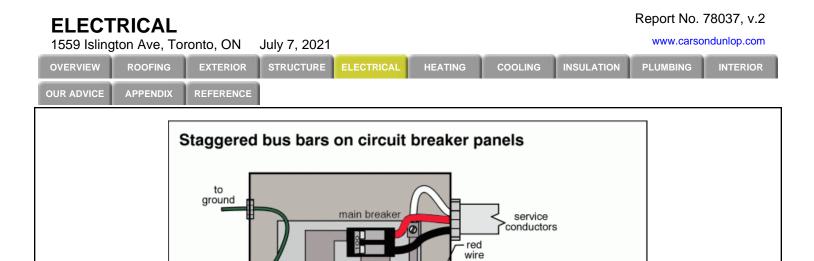
Condition: • <u>No links for multi-wire circuits</u> Location: Panel Task: Further evaluation

black wire

neutral

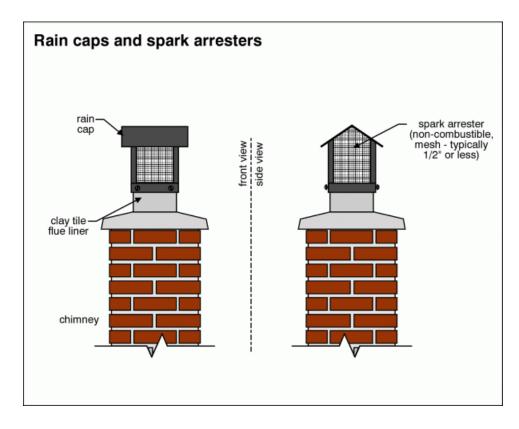
Condition: • Rain cap missing or damaged

*Provide rain screen(s) to help prevent moisture and vermin entry.

Time: As soon as practical

Cost: Minor

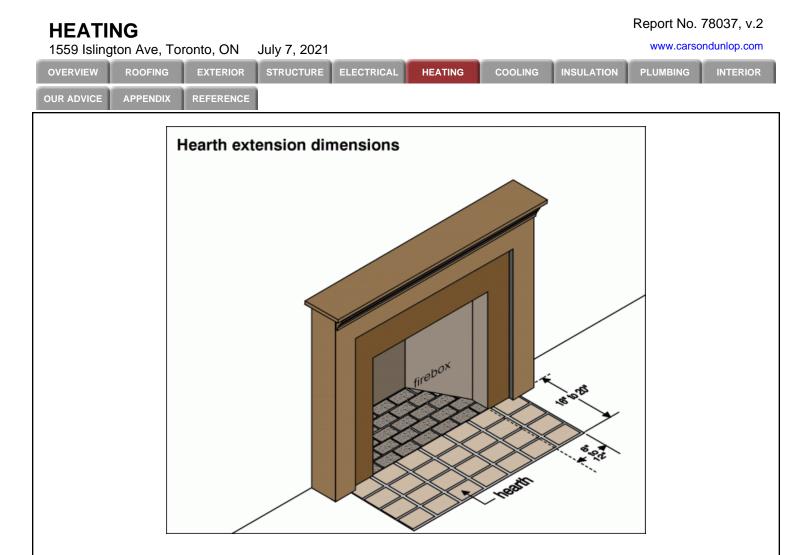
Condition: • Before you use the fireplace, it should be inspected, cleaned and improved if necessary by a WETT (Wood Energy Technology Transfer Inc.) certified technician
 Task: Provide
 Time: Before using

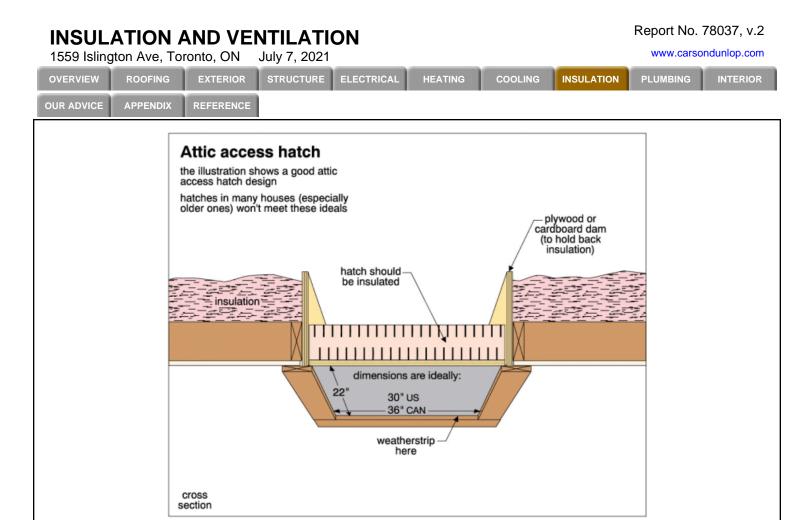
Condition: • Not weatherstripped

*Provide weather-stripping around access hatch to limit air leakage into/out of attic space. Ensure insulation the back side of the hatch is in good condition and well secured.

Time: Less than 1 year

Cost: Minor

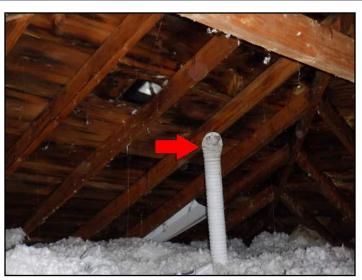
Condition: • Not vented to exterior

Not vented to exterior. Not insulated

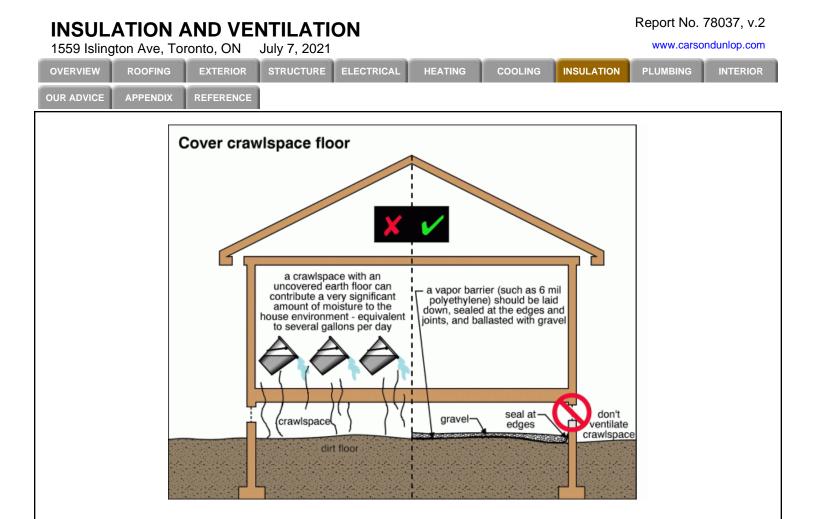
Condition:
 No vapor barrier

*Vapor barrier not visible. Excess moisture from ground may enter home here. Plastic should be sealed against the perimeter of the crawlspace to help prevent moisture/dampness from entering home through dirt floor. **No ventilation visible.

Task: Provide

Time: If missing

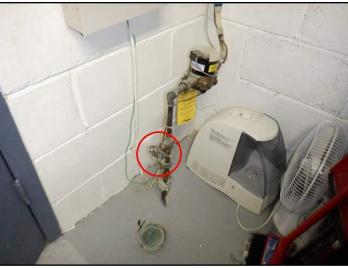
· Front of the basement

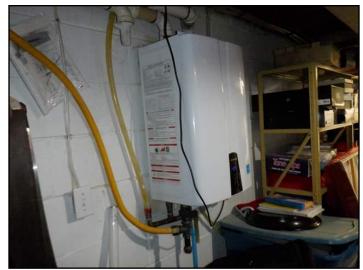
• Tankless/On demand

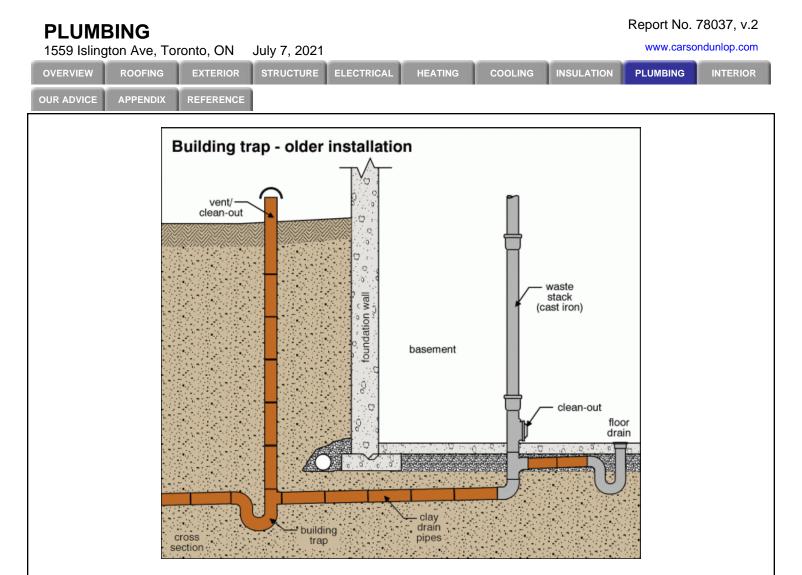
Condition: • Clean-outs missing or inaccessible May be concealed. Task: Locate, or provide if missing Time: Discretionary. **Cost**: Minor if a clean out is in place (typical). Up to \$1000 if there is none.

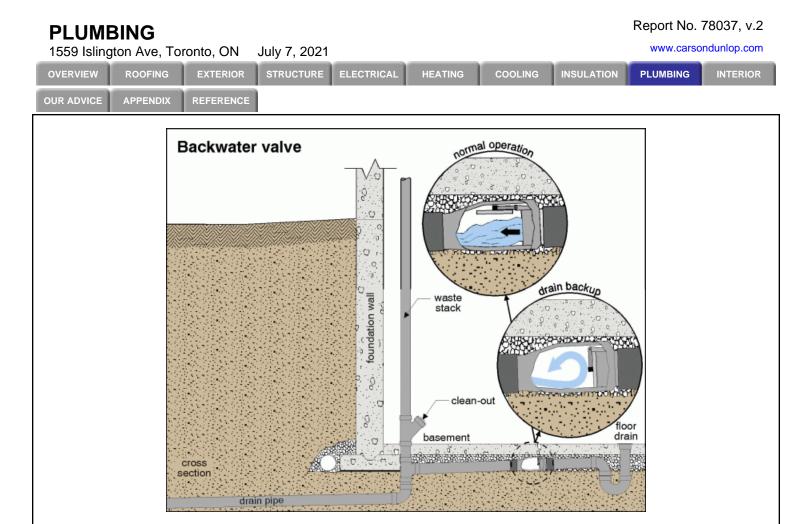
Condition: • None noted

Adding a backwater valve to the main drain line is an improvement you may consider to help protect your home against sewer backups. Some municipalities provide rebates or financial assistance for installing these devices. Some insurance companies offer premium discounts or other benefits for homeowners with backwater valves. The cost is typically \$2,000 to \$4,000, with \$2,500 being a common number. Once installed, they should be inspected twice annually.

Location: Basement Task: Provide Time: Discretionary Cost: \$2,000 - \$4,000
